Haymarket Town Council
15000 Washington Street, #100, Haymarket, Virginia 20169
Monday, December 5, 2011 – Mayor Pamela E. Stutz

Structural Engineer Report

Date: November 28, 2011 (revised)
Subject: Old Post Office Building, Haymarket, VA

Date: December 1, 2011
Subject: Hulfish House, Haymarket, VA

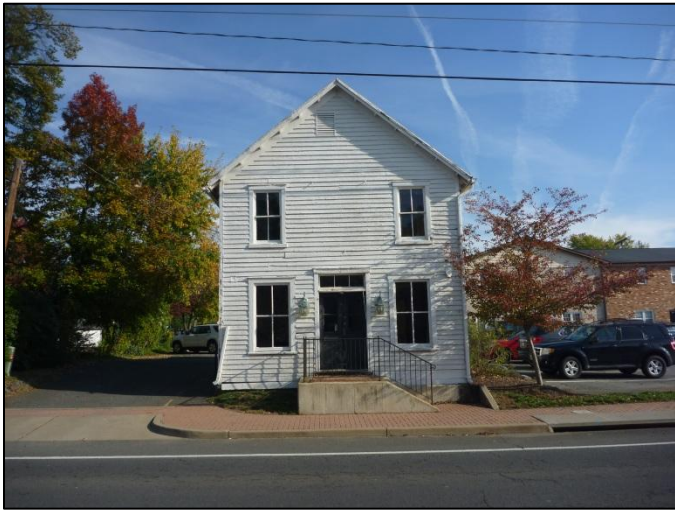
Front View of Ex. Building

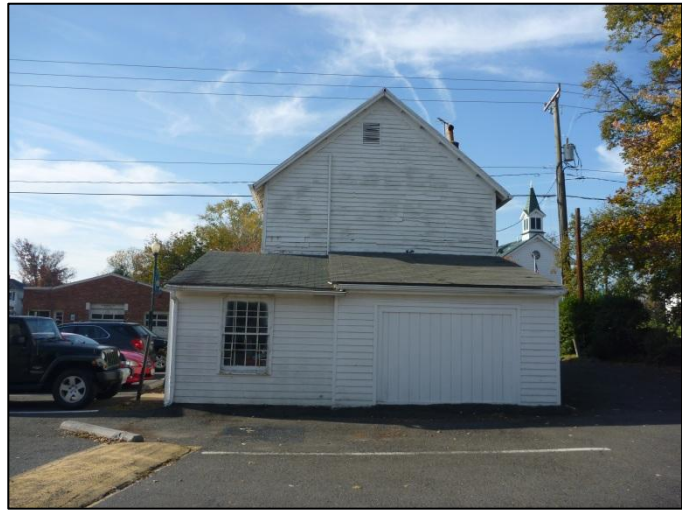
Rear View of Ex. Building

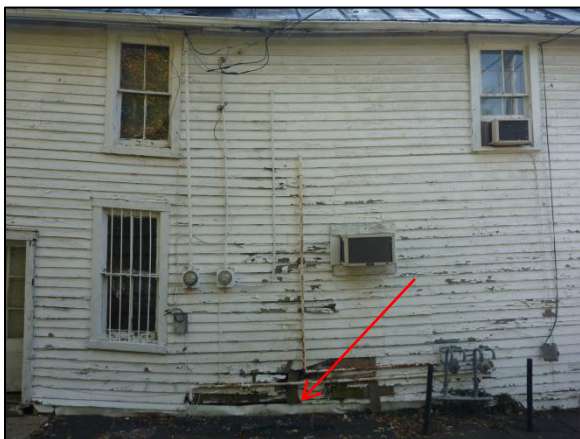
The building is a two-story wood framed building which is supported by a stone foundation. The original structure, consisting of the two-stories is eligible for the Virginia Historical Register and was originally constructed in the late 1800's or early 1900's. Two small additions were later added to the rear of the original building. Both the first and 2nd floor of the structure are framed with 2x8 floor joists spanning approximately 19'-4". The 2nd floor sags approximately 4" in the center and the 1st floor sags towards the chimney.. It is apparent from both the outside and inside that the foundation in the vicinity of the chimney has also failed. The following photos depict the condition:

View of left side of house at obvious foundation failure

It is understood that the Town would like to use the structure for light retail on the first floor and possible storage and/or offices on the 2nd floor. The existing floor joists on both floors are over spanned for light retail loading which requires a live load capacity of 50 pounds per square foot (psf). In order to accommodate this load it will be necessary to reinforce the structure as well as underpin the existing walls. The conceptual details and sequence for these repairs are shown on Exhibit A which is attached to this report. In summary this plan calls for the complete removal of the 1st floor and re-framing with a center support for the floor which will also carry up to the 2nd floor as well as the roof peak. The 1st floor will be allowed to “float” inside the building walls but be attached to the walls. The walls should be left as is (with a noticeable sag in framing but re-side exterior to hide sag) however, the base of the walls will need to be reconstructed and a concrete footer placed beneath the wall to brace the wall in place. The bottoms of the wall joists should be “sistered” where they are rotted and placed on a new sill plate to be placed on top of a footing (see Section View in exhibit A). It is recommended that the wall work be completed on the outside of the wall by removing the bottom three feet of the clapboard siding to access the wall framing from the outside. The sequence of work recommends milestones for re-inspection by the engineer.

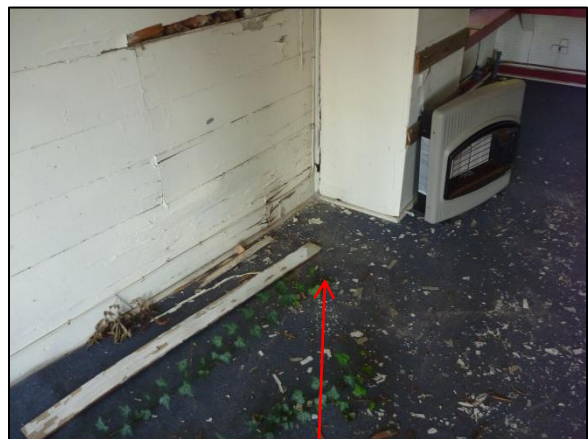
View of interior at chimney showing sagging floor

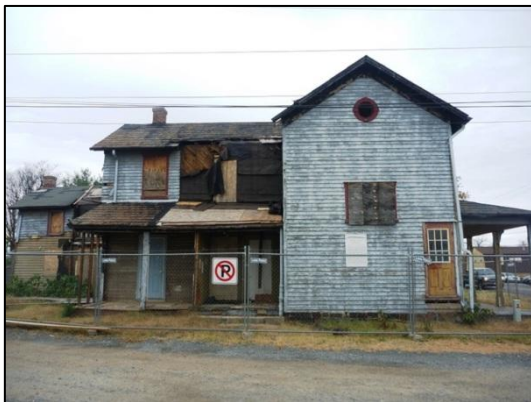
Photo 3 -View of left side of building

The main structure is in fair condition considering its age and non-use over the last several years. There is evidence of rotting wood in areas where the structure has leaked in the past. It is recommended that siding be removed in suspect areas and those areas be inspected by the engineer to confirm if repairs are necessary.

It is understood that the Town would like to use the main structure for light retail and/or offices on both the 1st and 2nd floor. The existing floor joists on both floors are over spanned for light retail or office loading which requires a live load capacity of 50 pounds per square foot (psf). In fact a check of the floor capacity shows that they do not meet residential loading either. In order to accommodate the required loading it will be necessary to reinforce the structure as well as repair rotted areas within the structure. The conceptual details and sequence for these repairs are shown on Exhibit A which is attached to this report. In summary this plan calls for the reinforcement of both the 1st and 2nd floors with shoring, reconstruction of the center bearing wall between the front and rear rooms, replacement or supplementing existing rotted floor joists and wall studs. The sequence of work recommends milestones for re-inspection by the engineer at various times to confirm existing conditions. It is also recommended that the cellar have a sump pump installed to keep water from flooding the space.

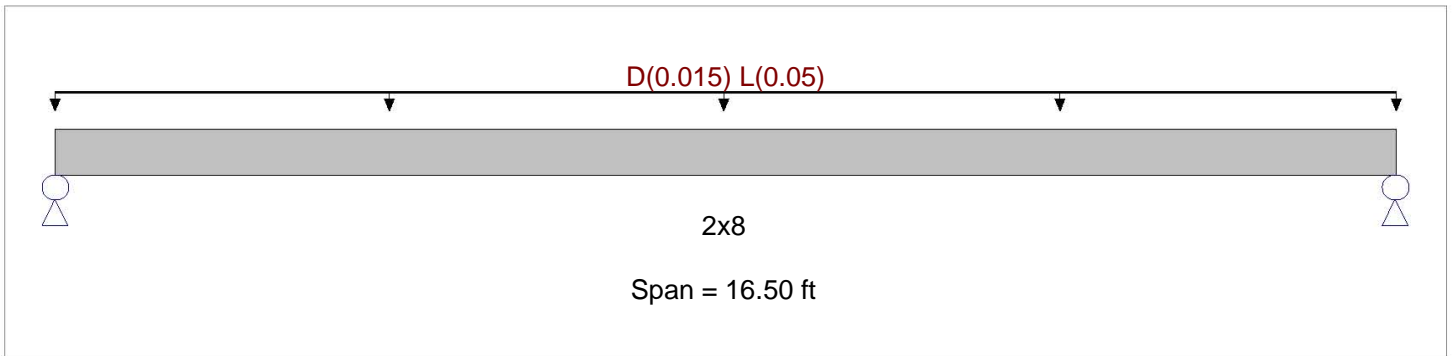
Description : check on ex. 1ST floor joists HULFISH HOUSE

Design N.G.

Maximum Bending Stress Ratio	=	1.683 : 1	Maximum Shear Stress Ratio	=	0.393 : 1
Section used for this span		2x8	Section used for this span		2x8
fb : Actual	=	2,020.02psi	fv : Actual	=	68.79 psi
FB : Allowable	=	1,200.00psi	Fv : Allowable	=	175.00 psi
Load Combination		+D+L+H	Load Combination		+D+L+H
Location of maximum on span	=	8.250ft	Location of maximum on span	=	15.923 ft
Span # where maximum occurs	=	Span # 1	Span # where maximum occurs	=	Span # 1
Maximum Deflection					
Max Downward L+Lr+S Deflection		1.103 in	Ratio =		179 < 360
Max Upward L+Lr+S Deflection		0.000 in	Ratio =		0 < 360
Max Downward Total Deflection		1.434 in	Ratio =		138 < 180
Max Upward Total Deflection		0.000 in	Ratio =		0 < 180
