TOWN OF HAYMARKET TOWN COUNCIL

WORK SESSION
~ AGENDA ~

Monday, November 5, 2018

1. Haymarket Historic Foundation
2. Architectural Review Board Appeal - 14801 Washington Street

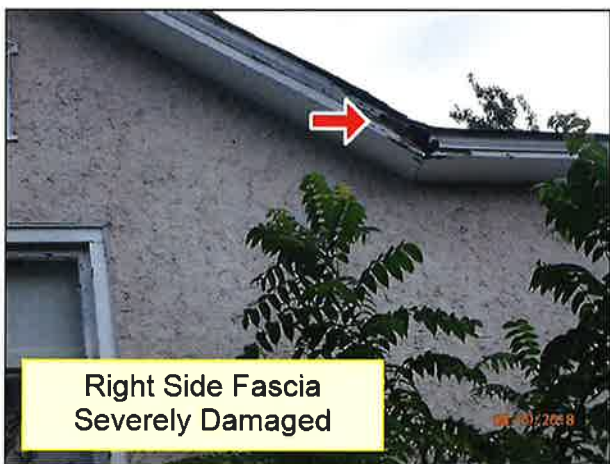
1.1 FASCIA / SOFFITS (Picture 1)

Decay noted on fascia boards on all sides of the structure with major damage along the right side where the rear addition is connected to the primary structure and the rear left corner of the addition. This damage is not visible from the attic as it is primarily associated with how the addition was attached to the main home. However, the visual damage to the fascia boards and associated rafters is quite extensive and may include adjoining rafters as well.

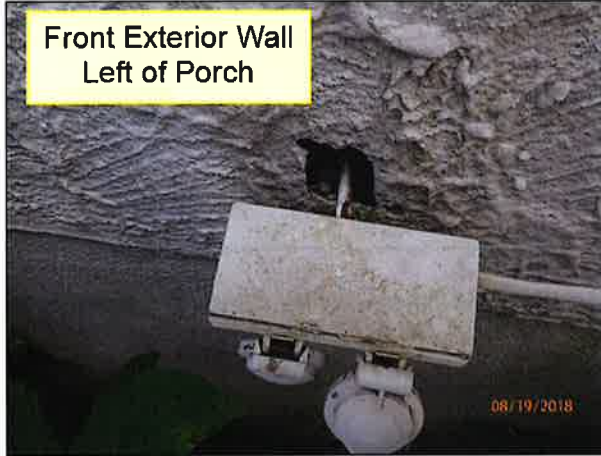
2.0 SIDING / WALL CLADDING (Picture 1)

The stucco surface throughout the exterior of the home is in generally fair condition. Having stucco installed over a wooden structure incorporates reinforcement mesh and a textured finish coating. These products and/or installation methods create conditions that are highly susceptible to moisture infiltration and subsequent mold growth and/or structural damage due to water infiltration at penetrations, joints, and roof terminations.

Several cracks were noted in the stucco coating throughout the outside of the structure with several points where internal structural damaged was noted including;

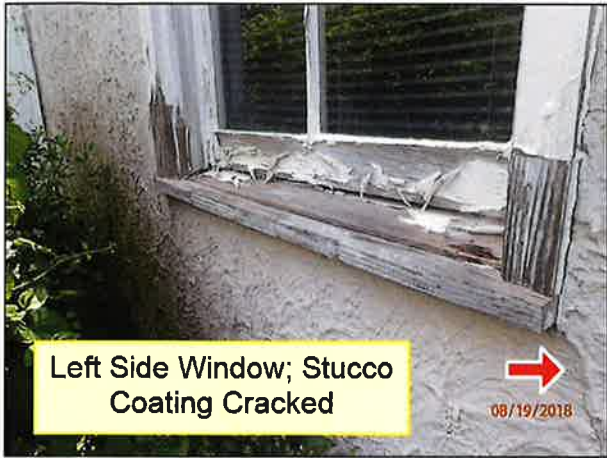
2.0 SIDING / WALL CLADDING (Picture 7)

Left Side Window; Stucco Coating Cracked

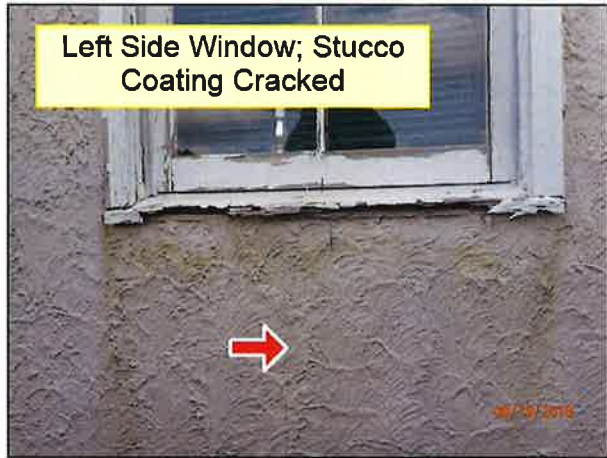
2.0 SIDING / WALL CLADDING (Picture 8)

Left Side Window; Stucco Coating Cracked

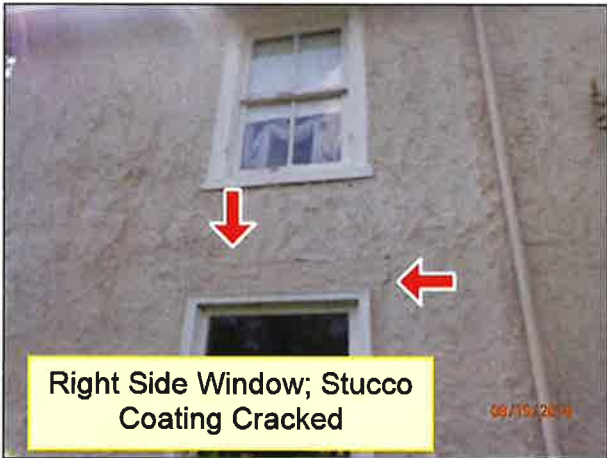
2.0 SIDING / WALL CLADDING (Picture 9)

Right Side Window; Stucco Coating Cracked

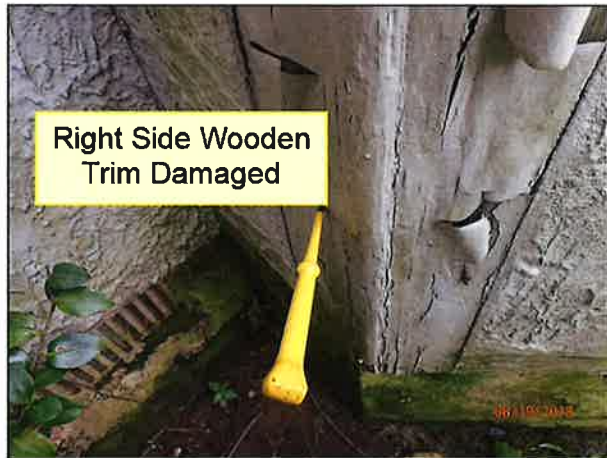
2.1 WOOD TRIM / WRAPS (Picture 1)

Virtually all exterior wooden trim has been damaged by a combination of wood destroying insects and water intrusion.

Right Side Wooden Trim Damaged

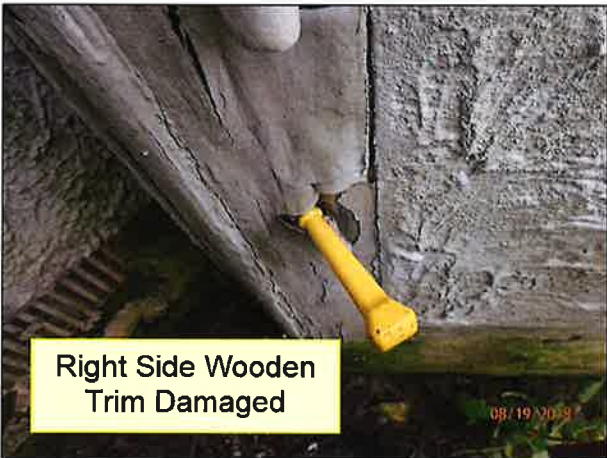
2.1 WOOD TRIM / WRAPS (Picture 2)

Right Side Wooden Trim Damaged

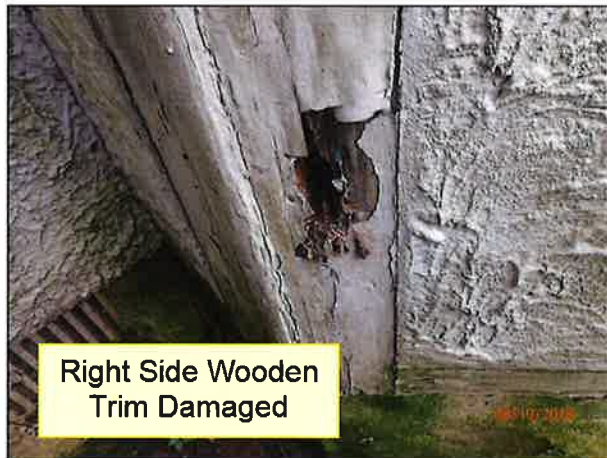
Right Side Wooden Trim Damaged

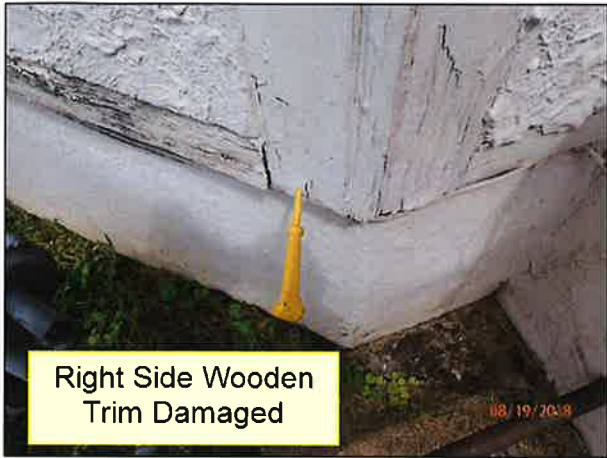
2.1 WOOD TRIM / WRAPS (Picture 10)

Right Side Wooden Trim Damaged

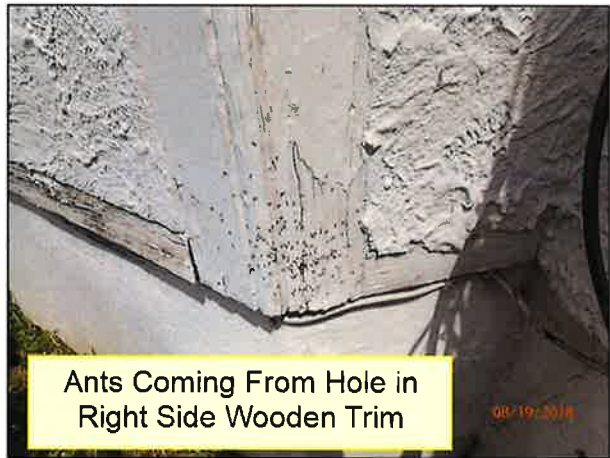
2.1 WOOD TRIM / WRAPS (Picture 11)

Ants Coming From Hole in Right Side Wooden Trim

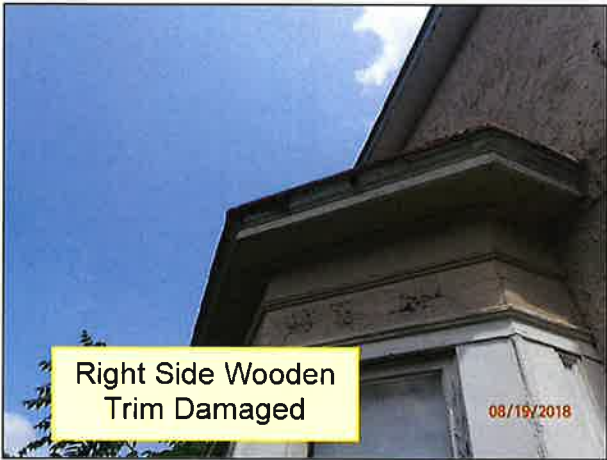
2.1 WOOD TRIM / WRAPS (Picture 12)

Right Side Wooden Trim Damaged

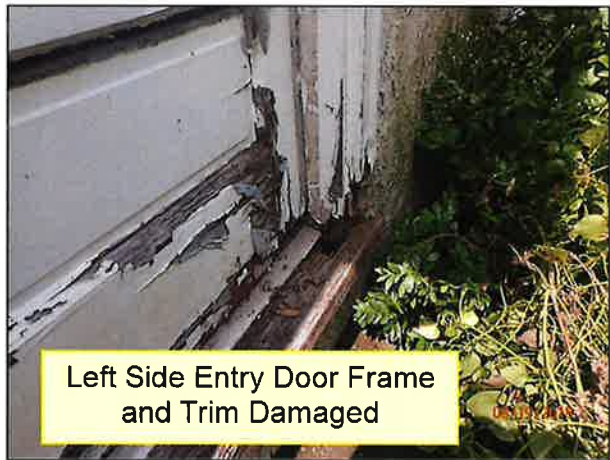
2.1 WOOD TRIM / WRAPS (Picture 13)

Left Side Entry Door Frame and Trim Damaged

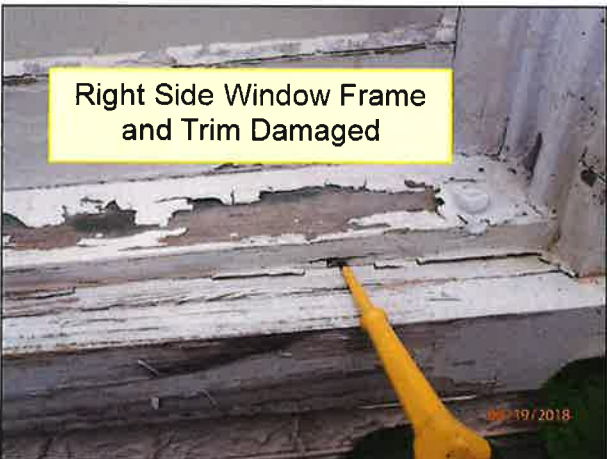
2.2 WINDOWS (Picture 1)

Virtually all window frames and trim has been damaged by a combination of wood destroying insects and water intrusion.

Right Side Window Frame and Trim Damaged

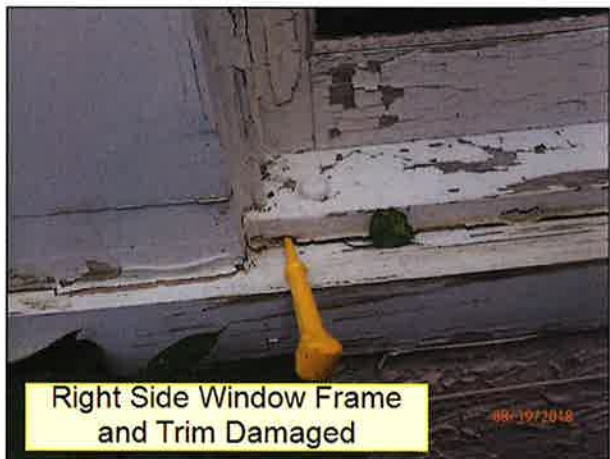
2.2 WINDOWS (Picture 2)

Right Side Window Frame and Trim Damaged

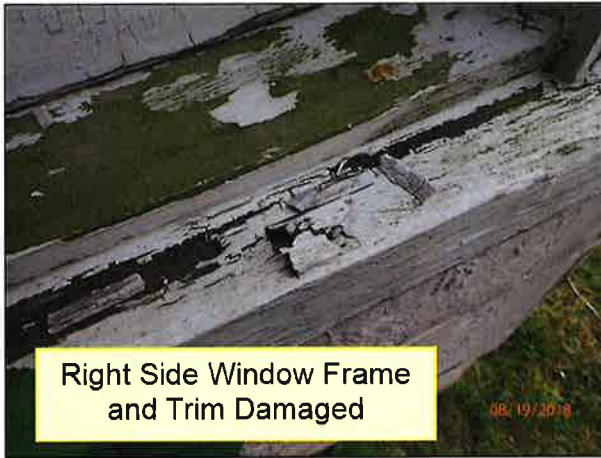
2.2 WINDOWS (Picture 3)

Right Side Window Frame and Trim Damaged

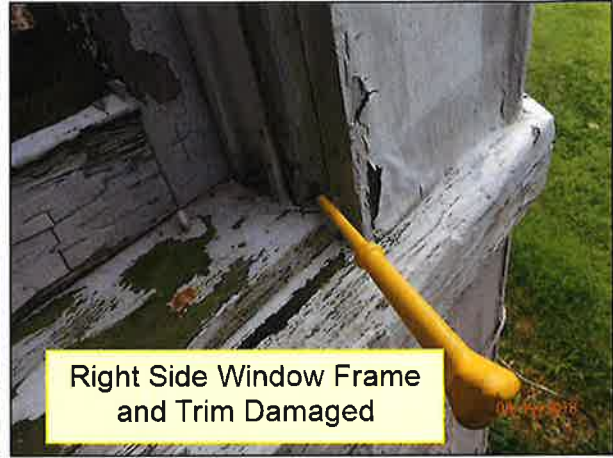
2.2 WINDOWS (Picture 4)

Right Side Window Frame and Trim Damaged

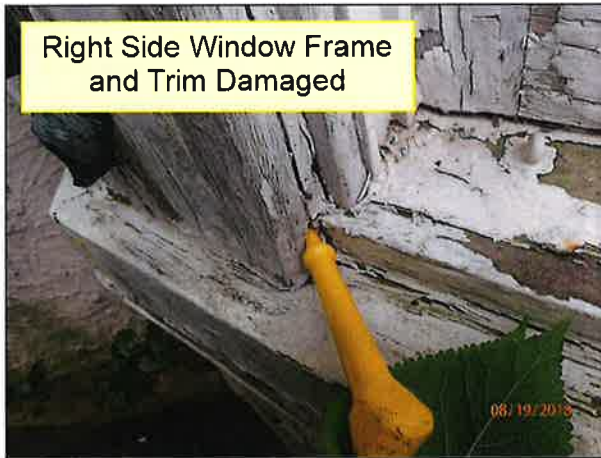
2.2 WINDOWS (Picture 5)

Right Side Window Frame and Trim Damaged

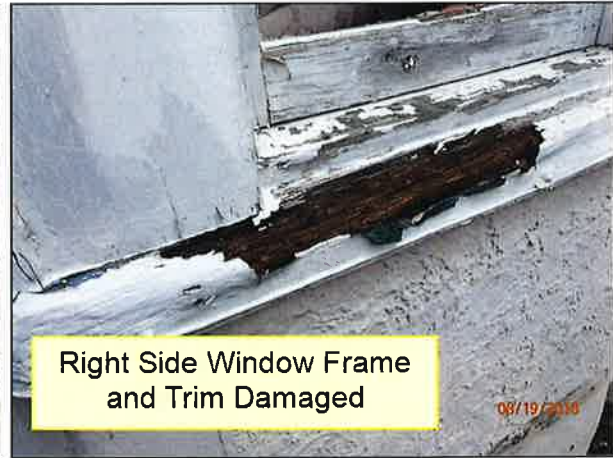
2.2 WINDOWS (Picture 6)

Right Side Window Frame and Trim Damaged

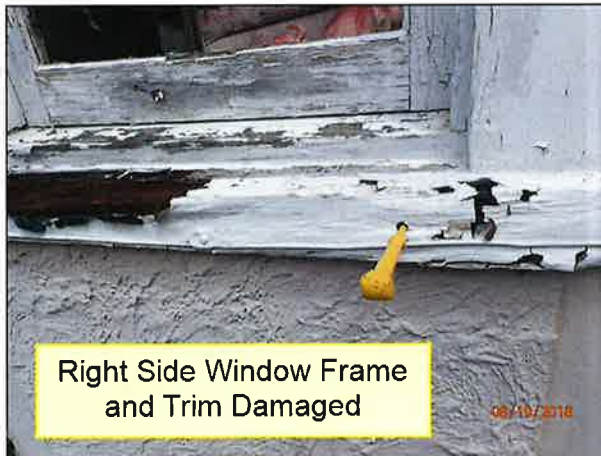
2.2 WINDOWS (Picture 7)

Right Side Window Frame and Trim Damaged

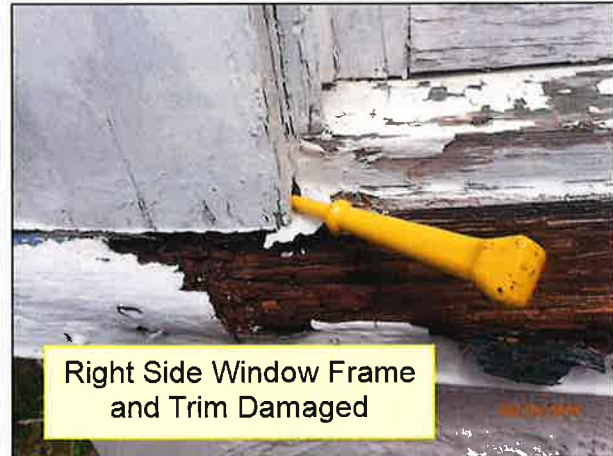
2.2 WINDOWS (Picture 8)

Right Side Window Frame and Trim Damaged

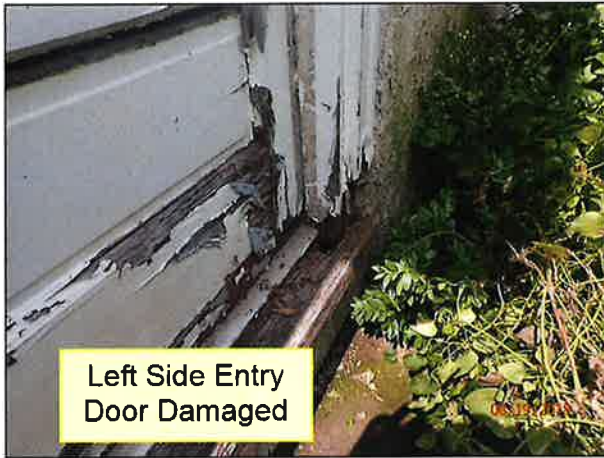
2.3 ENTRY DOORS (Picture 1)

The left side entry door and frame to the enclosed room that was once part of the wrap around porch has been damaged by a combination of wood destroying insects and water intrusion.

Left Side Entry Door Damaged

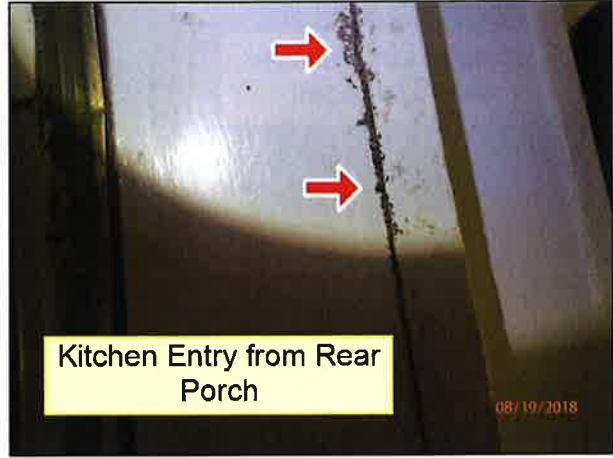
2.3 ENTRY DOORS (Picture 2)

Kitchen entry door from rear porch has a damaged frame and trim. Wood destroying insects have damaged the framing behind the trim such that frass is being extruded from the gaps in the frame.

Kitchen Entry from Rear Porch

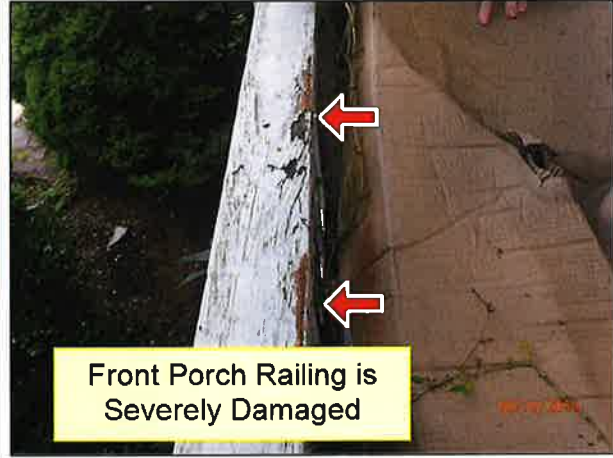
2.4 RAILINGS (Picture 1)

The front porch railing is severely damaged by a combination of wood destroying insects and water intrusion.

Front Porch Railing is Severely Damaged

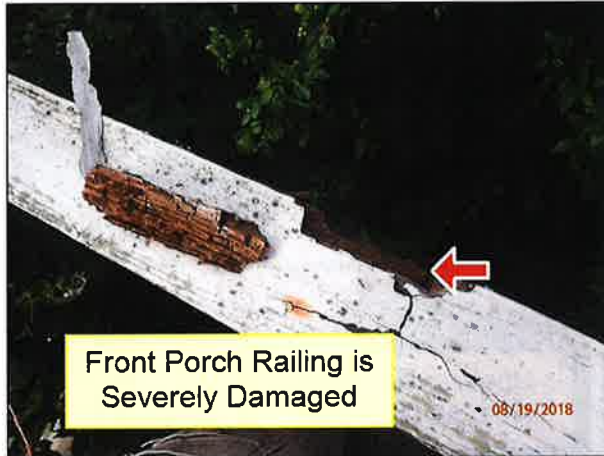
2.4 RAILINGS (Picture 2)

Front Porch Railing is Severely Damaged

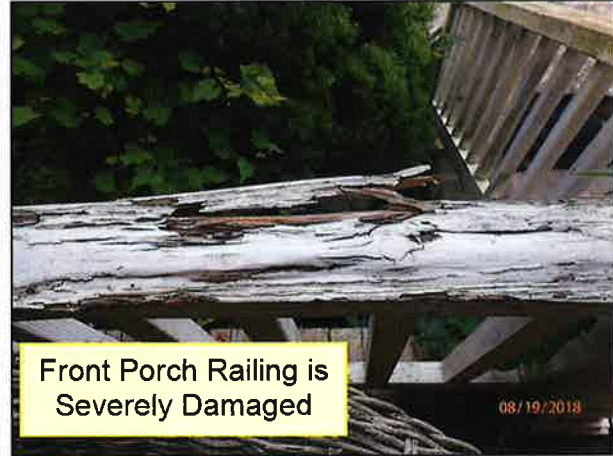
2.4 RAILINGS (Picture 3)

Front Porch Railing is Severely Damaged

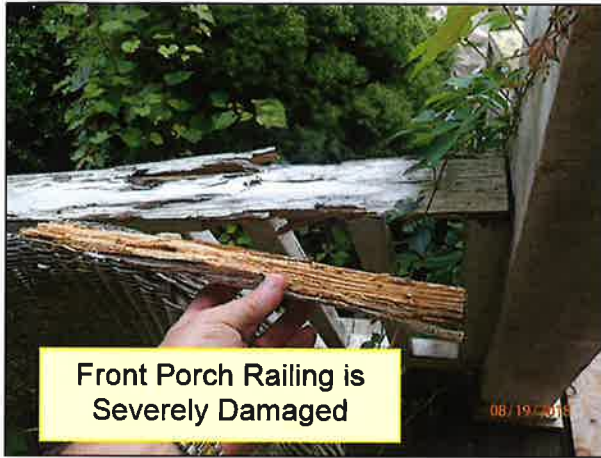
2.4 RAILINGS (Picture 4)

Front Porch Railing is Severely Damaged

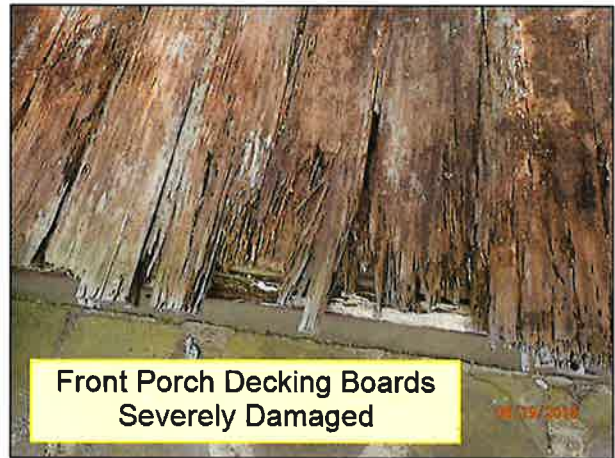
2.5 FRONT PORCH (Picture 1)

The deck of the front porch is severely damaged by a combination of wood destroying insects and water intrusion.

Front Porch Decking Boards Severely Damaged

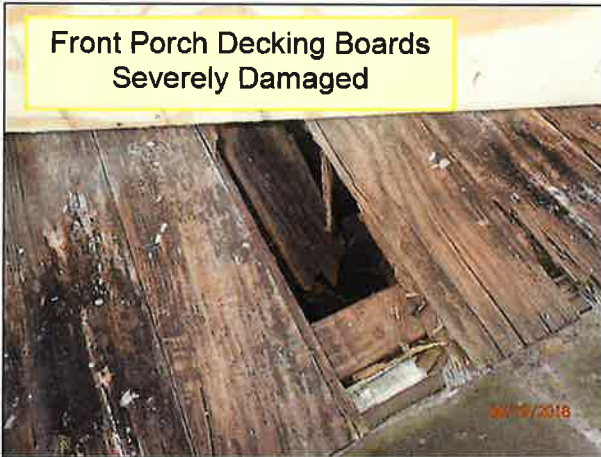
2.5 FRONT PORCH (Picture 2)

Front Porch Decking Boards Severely Damaged

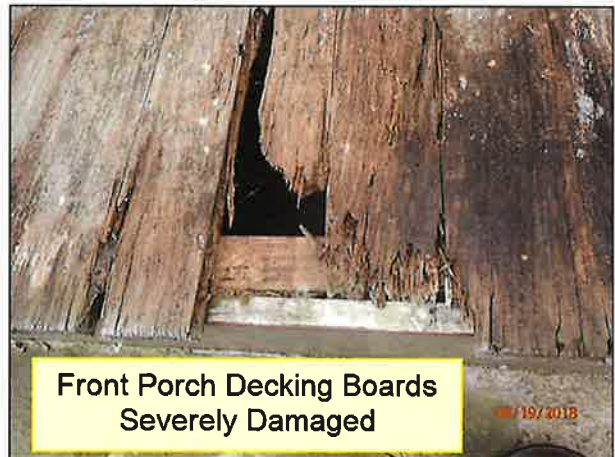
2.5 FRONT PORCH (Picture 3)

Front Porch Decking Boards Severely Damaged

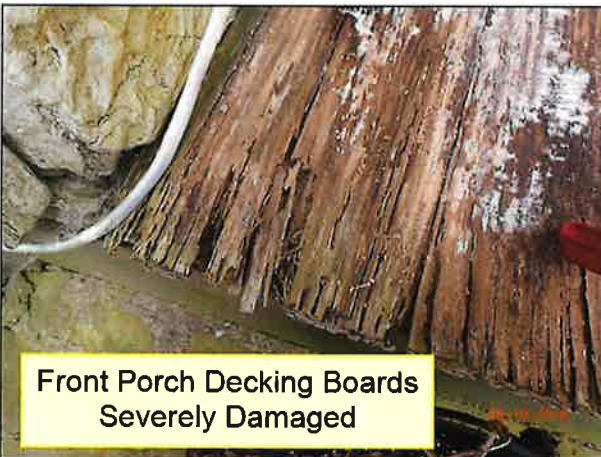
2.5 FRONT PORCH (Picture 4)

Front Porch Decking Boards Severely Damaged

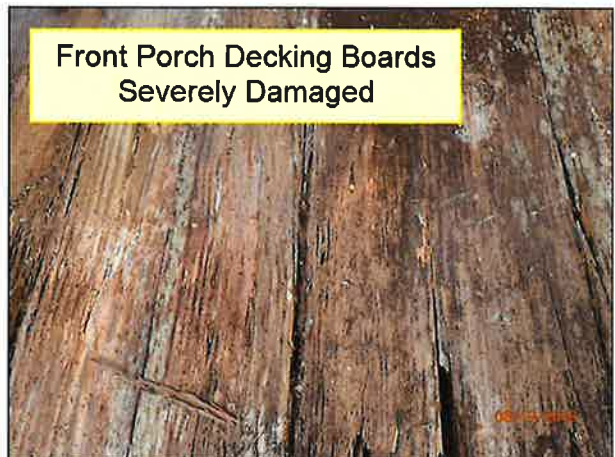
2.5 FRONT PORCH (Picture 5)

Front Porch Decking Boards Severely Damaged

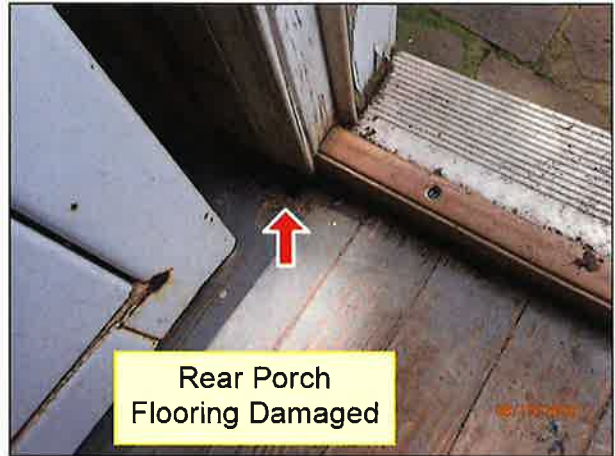
2.6 REAR PORCH (Picture 1)

The rear porch flooring is severely damaged by a combination of wood destroying insects and water intrusion. The entire rear porch floor needs to be removed and replaced. Damage to the rear porch framing exist under the three primary points accessible through the damaged flooring it is quite possible that other damage exists as well.

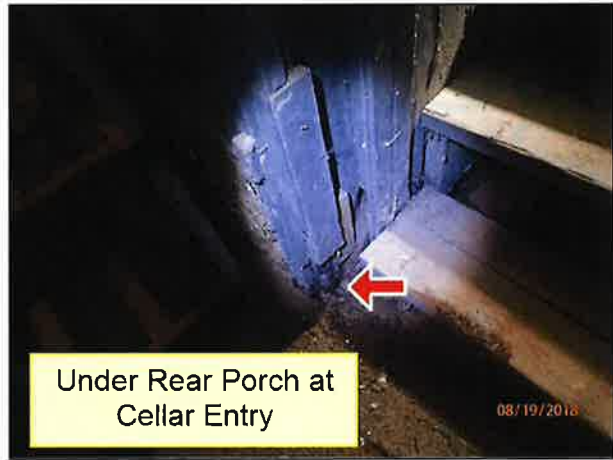
2.6 REAR PORCH (Picture 9)

Cellar entry under rear porch is heavily damaged by wood destroying insects. Frass was noted in the framing around the cellar entry doorway.

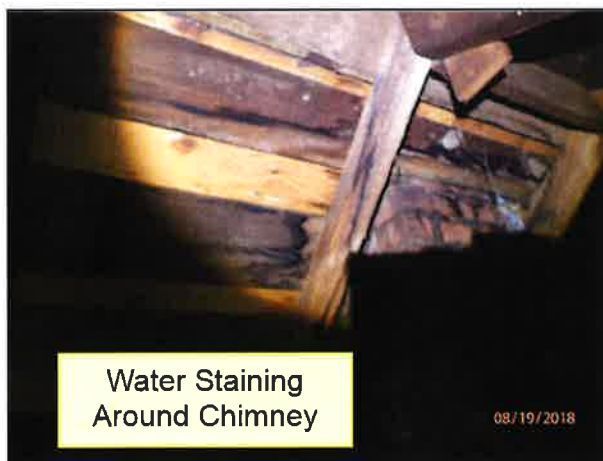
Water Staining Around Chimney

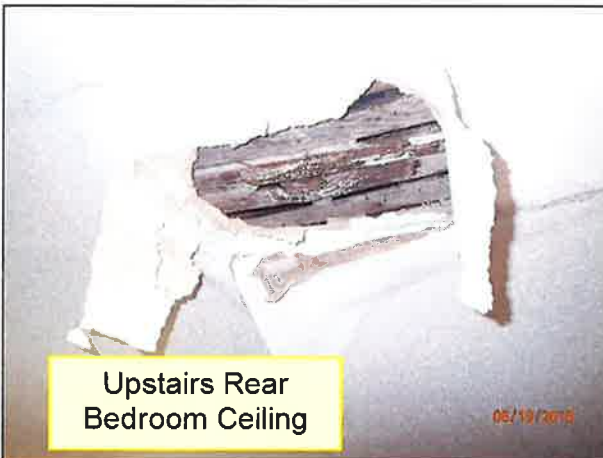
4.0 CEILINGS / STRUCTURE (Picture 1)

All rooms within the structure that are not under the original structure with the attic have significant ceiling damage from water intrusion. The plaster is falling/fallen from the ceiling, is cracked, or is bowing from moisture that has allowed it to separate from the lath backing. In some cases the lath has separated from the rafters as well.

Upstairs Rear Bedroom Ceiling

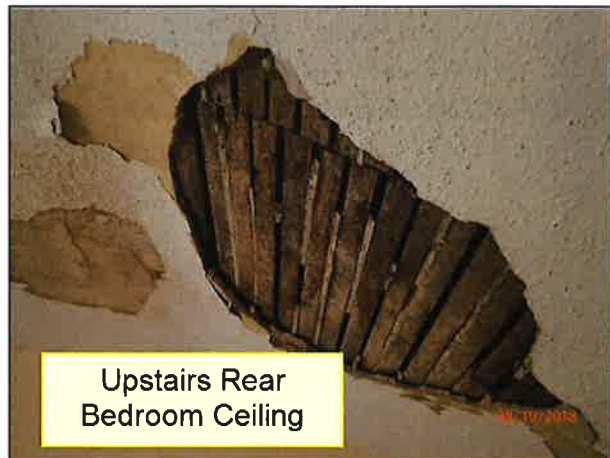
4.0 CEILINGS / STRUCTURE (Picture 2)

Upstairs Rear Bedroom Ceiling

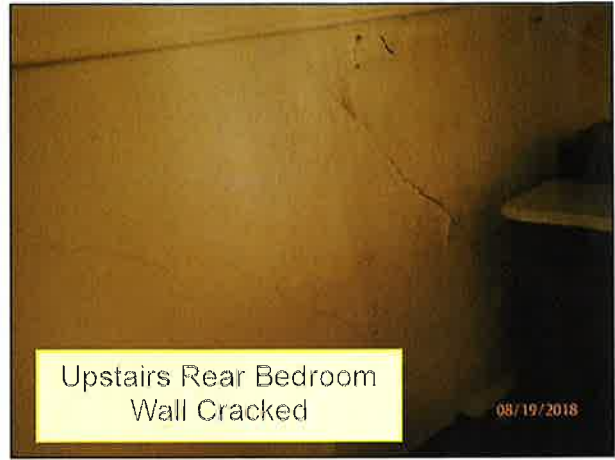
4.1 WALLS / STRUCTURE (Picture 1)

Walls throughout the structure are cracked and/or damaged. This may be a sign of water infiltration as the cracks are in the area of prior noted ceiling damage as well and under windows with prior noted significant damage to the frames.

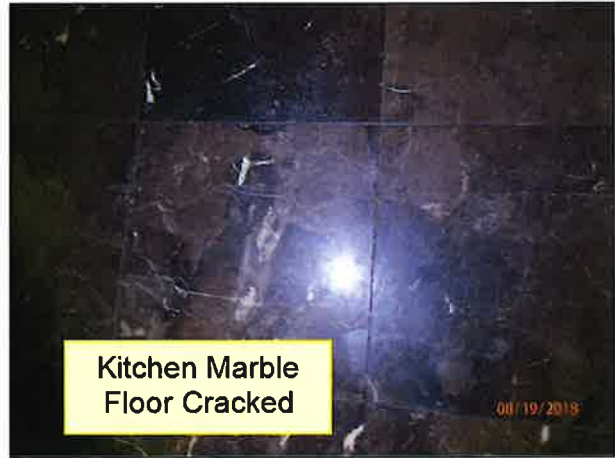
4.2 FLOORS (FRAMED) (Picture 2)

The dining room floor has a spot of damage consistent with wood destroying insects.

The sitting room floor has a separation gap where the foundation ends and the cantilevered bumpout begins. This may be a sign of significant damage to the framing below the floor. The sitting room bumpout has significant damage to the framing and wooden trim as well.

The kitchen marble floor has several cracks in all areas. This may be a result of significant damage to the framing below as the flooring at the wall adjoining the kitchen has significant damage as well.
