TOWN OF HAYMARKET TOWN COUNCIL Regular Meeting

Monday, November 5, 2018

The home currently requires major repairs for individuals to safely occupy the space. The owner of the property does not wish to make this investment and is ready to have the structure torn down. The home is considered a historic structure based on its age, over 50 years, the home was built in 1909. This structure is listed on the Town of Haymarket's Historic Structures List as the *Jordan House, 14801 Washington Street*.

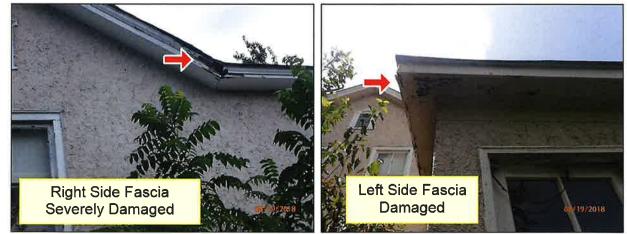
1.1 FASCIA / SOFFITS (Picture 1)

Decay noted on fascia boards on all sides of the structure with major damage along the right side where the rear addition is connected to the primary structure and the rear left corner of the addition. This damage is not visible from the attic as it is primarily associated with how the addition was attached to the main home. However, the visual damage to the fascia boards and associated rafters is quite extensive and may include adjoining rafters as well.

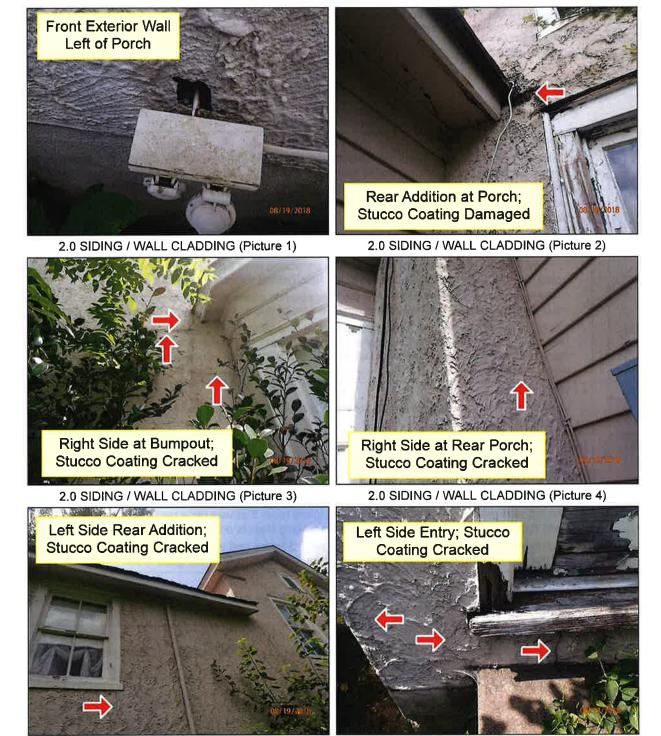
2.0 SIDING / WALL CLADDING (Picture 5)

The stucco surface throughout the exterior of the home is in generally fair condition. Having stucco installed over a wooden structure incorporates reinforcement mesh and a textured finish coating. These products and/or installation methods create conditions that are highly susceptible to moisture infiltration and subsequent mold growth and/or structural damage due to water infiltration at penetrations, joints, and roof terminations.

Several cracks were noted in the stucco coating throughout the outside of the structure with several points where internal structural damaged was noted including;

1. Front wall left of front porch, receptacle is separated from the wall and decayed/damaged wood was noted directly inside the wall adjacent to the hole behind the stucco coating.

2. Right side rear addition wall where the rear porch is attached has a large hole with the reinforcement mesh is clearly visible. The wooden structure behind this has been compromised and is decayed.

It is quite possible that additional damage to the original wooden structure exists given the damage at the areas that were accessible. The only way to fully assess the damage is to take core samples by drilling through the stucco coating at points where the stucco coating is cracked and extracting and assessing the wood shavings.

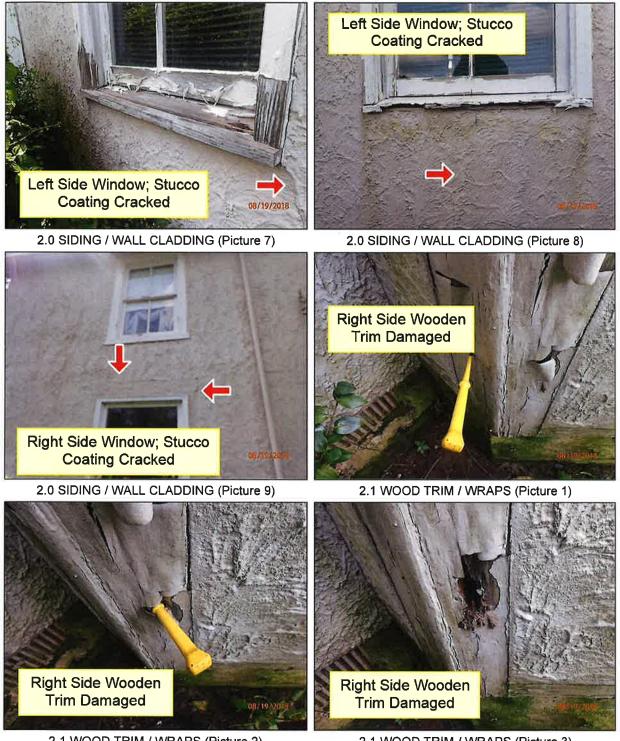
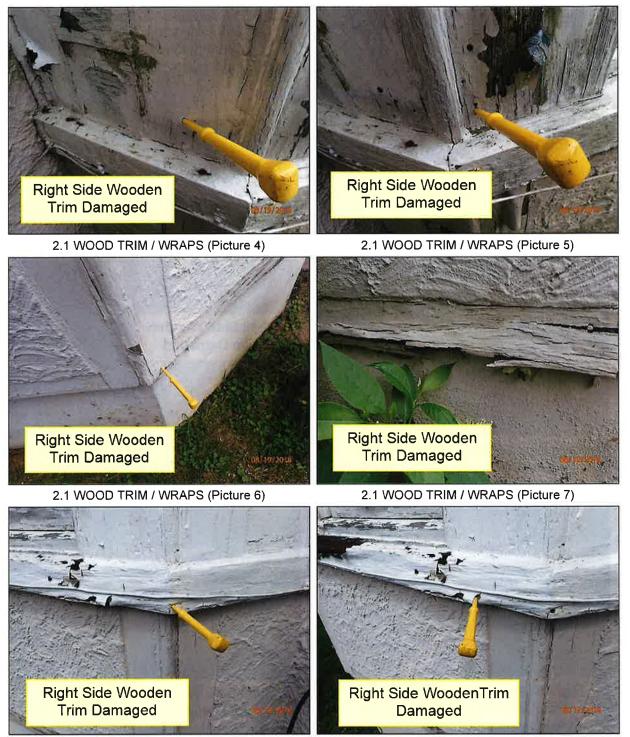
2.1 WOOD TRIM / WRAPS (Picture 2)

Virtually all exterior wooden trim has been damaged by a combination of wood destroying insects and water intrusion.

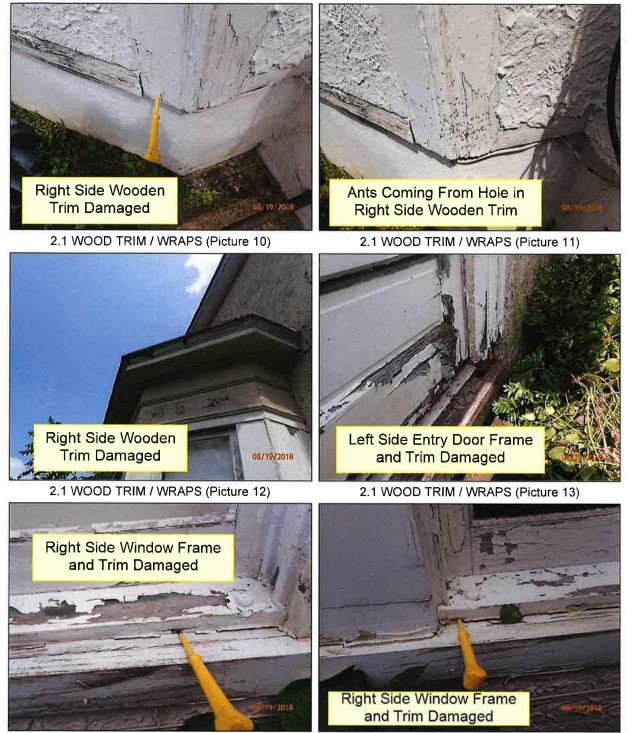
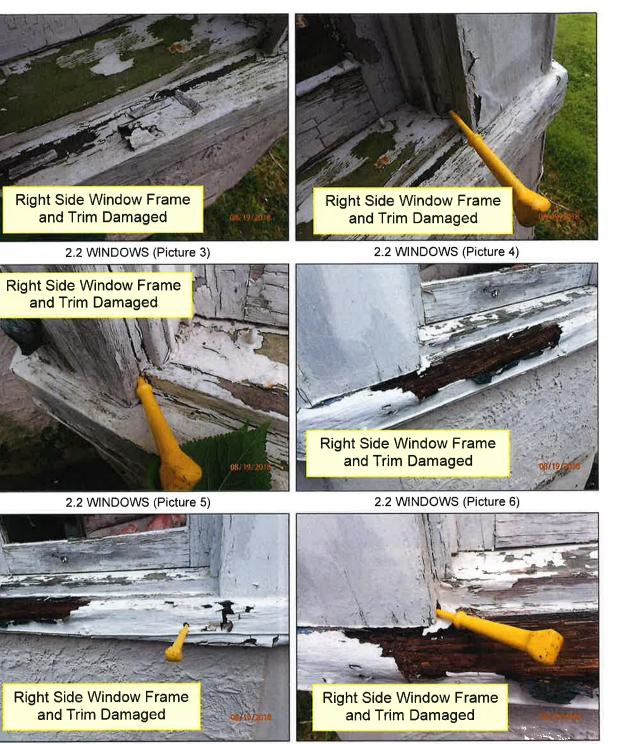
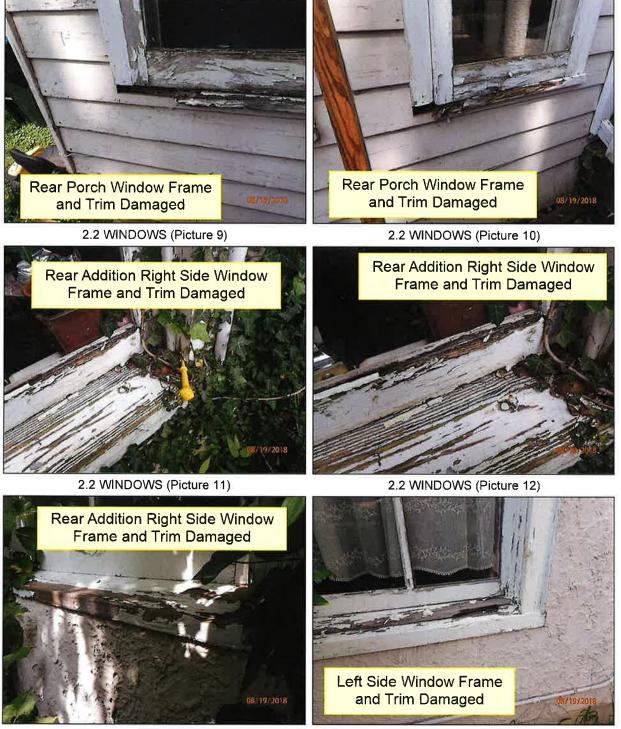
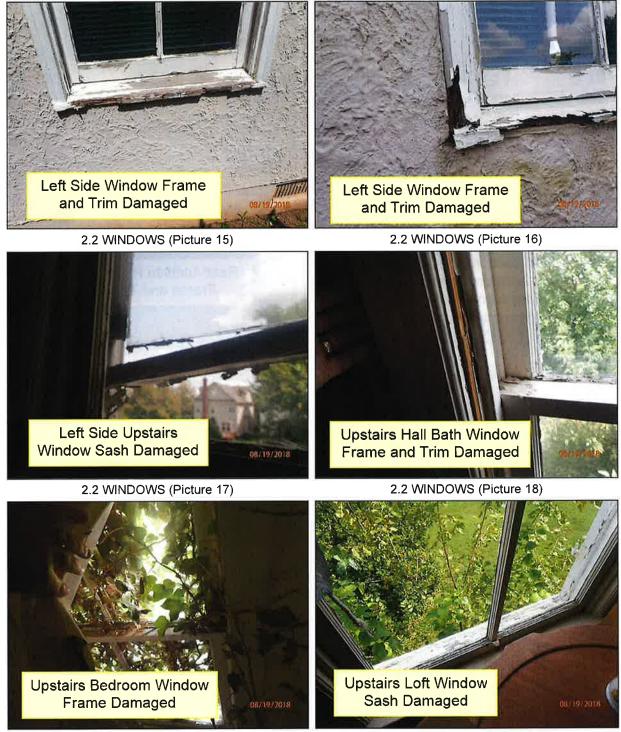
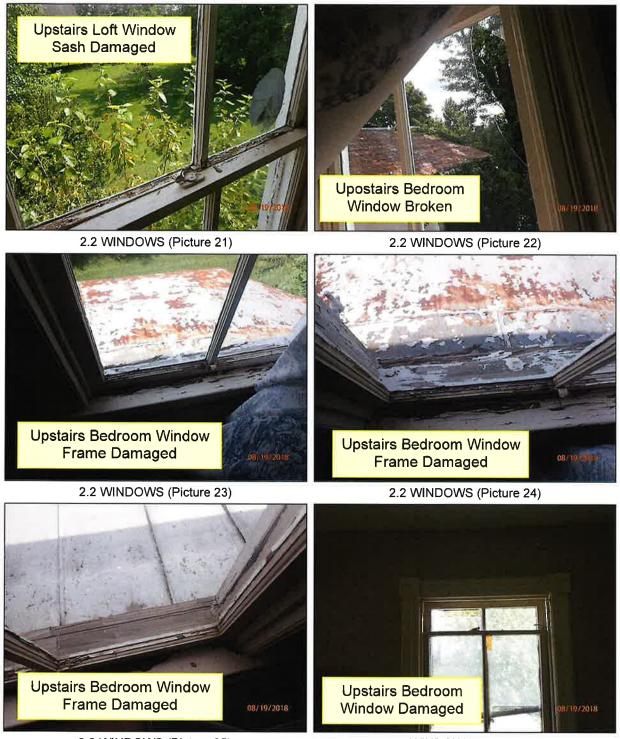
2.2 WINDOWS (Picture 1)

Virtually all window frames and trim has been damaged by a combination of wood destroying insects and water intrusion.

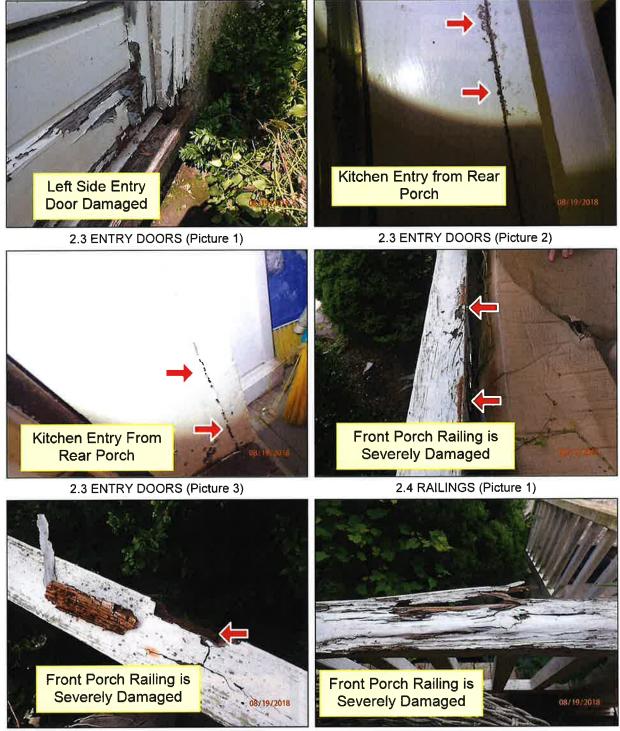
2.4 RAILINGS (Picture 2)

The front porch railing is severely damaged by a combination of wood destroying insects and water intrusion.

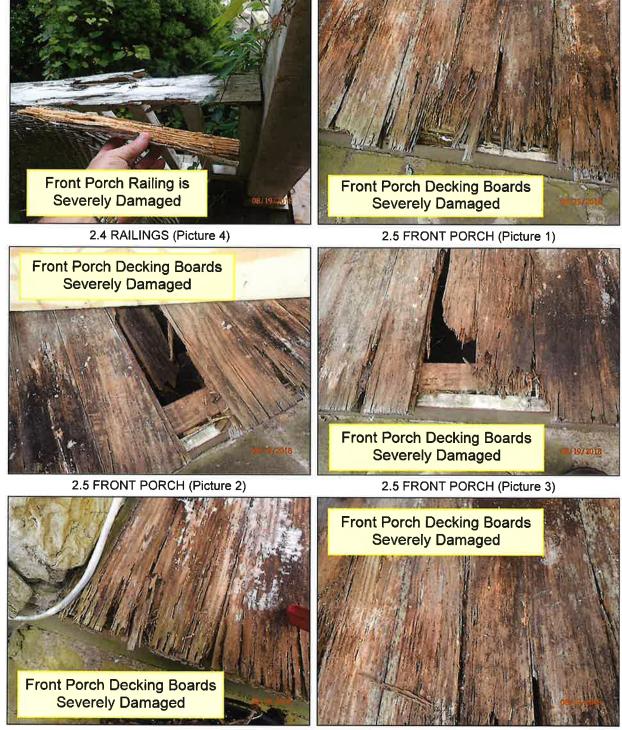
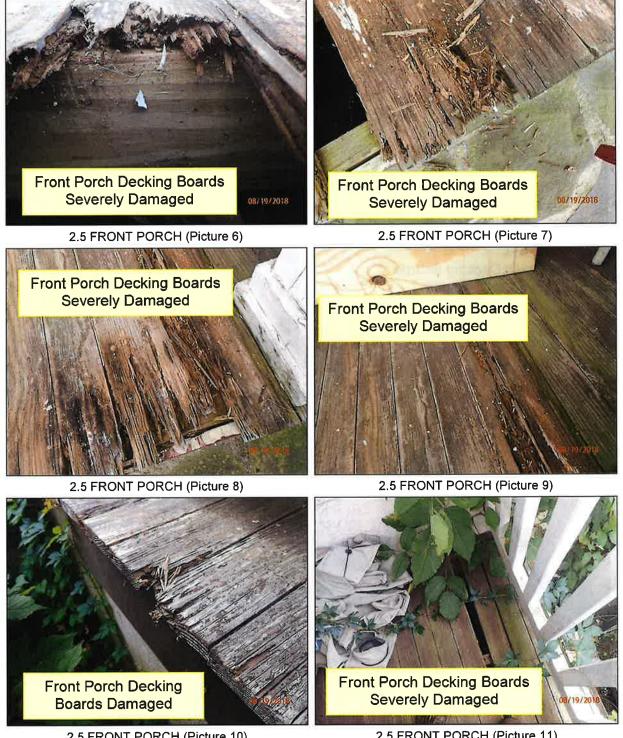
2.5 FRONT PORCH (Picture 4)

The deck of the front porch is severely damaged by a combination of wood destroying insects and water intrusion.

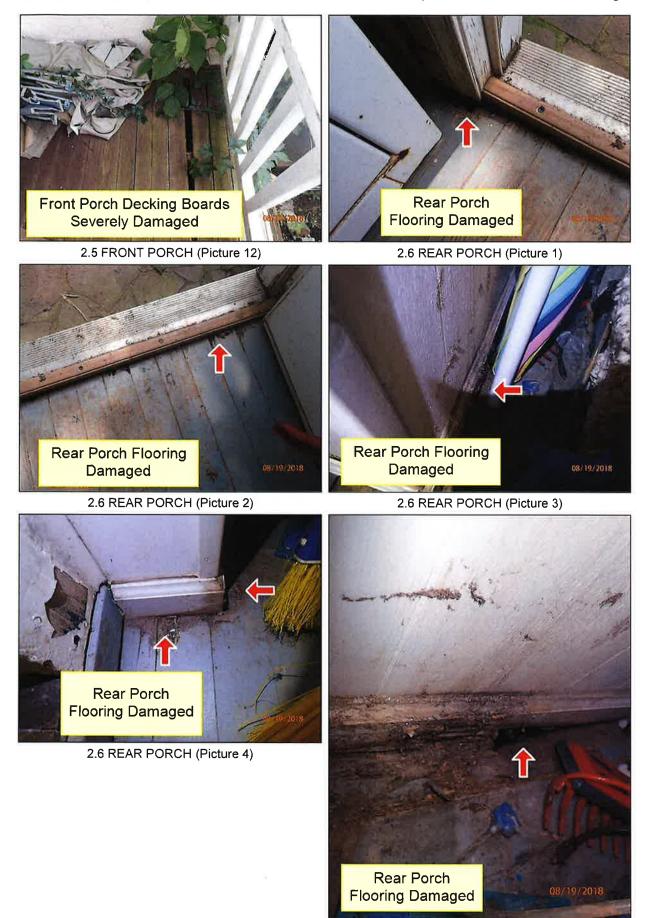
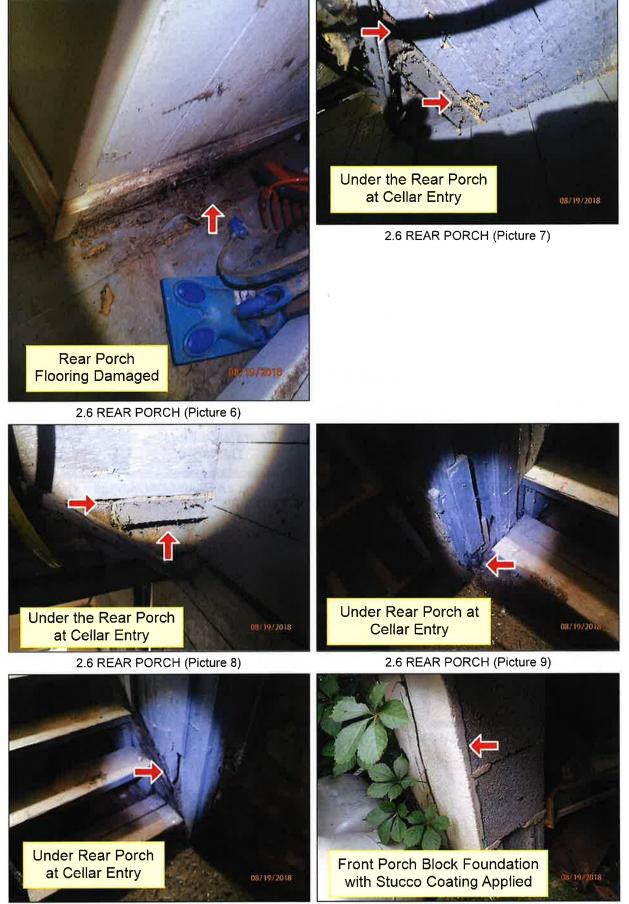
2.6 REAR PORCH (Picture 5)

The rear porch flooring is severely damaged by a combination of wood destroying insects and water intrusion. The entire rear porch floor needs to be removed and replaced. Damage to the rear porch framing exist under the three primary points accessible through the damaged flooring it is quite possible that other damage exists as well.

Cellar entry under rear porch is heavily damaged by wood destroying insects. Frass was noted in the framing around the cellar entry doorway.

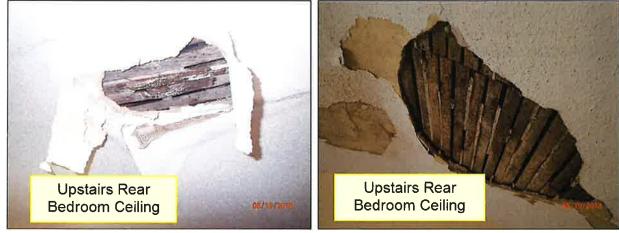
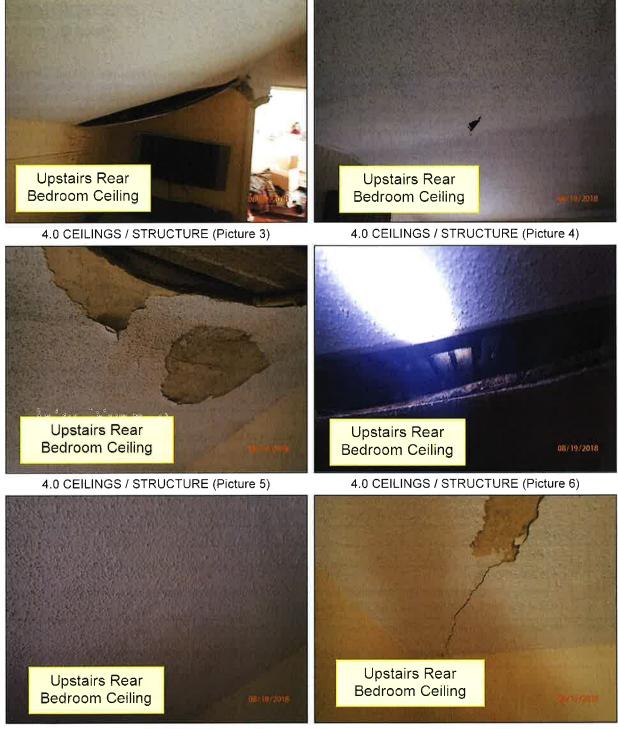
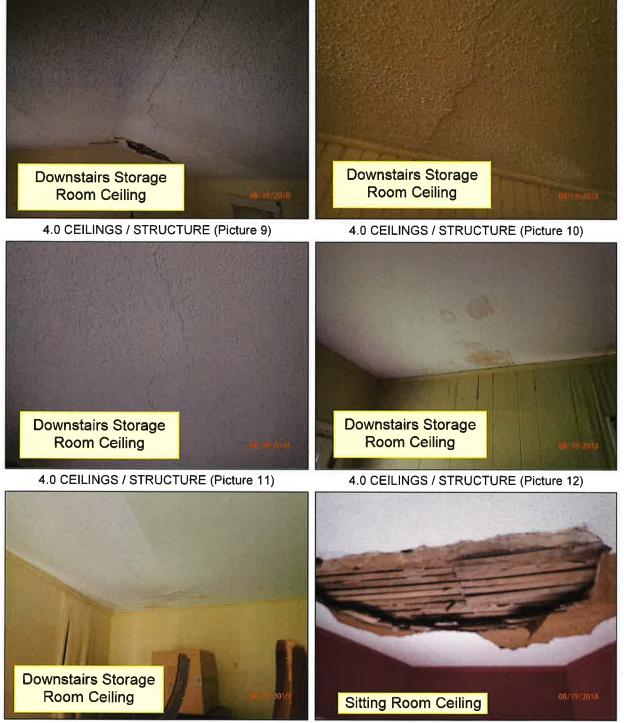
4.0 CEILINGS / STRUCTURE (Picture 1)

All rooms within the structure that are not under the original structure with the attic have significant ceiling damage from water intrusion. The plaster is falling/fallen from the ceiling, is cracked, or is bowing from moisture that has allowed it to separate from the lath backing. in some cases the lath has separated from the rafters as well.

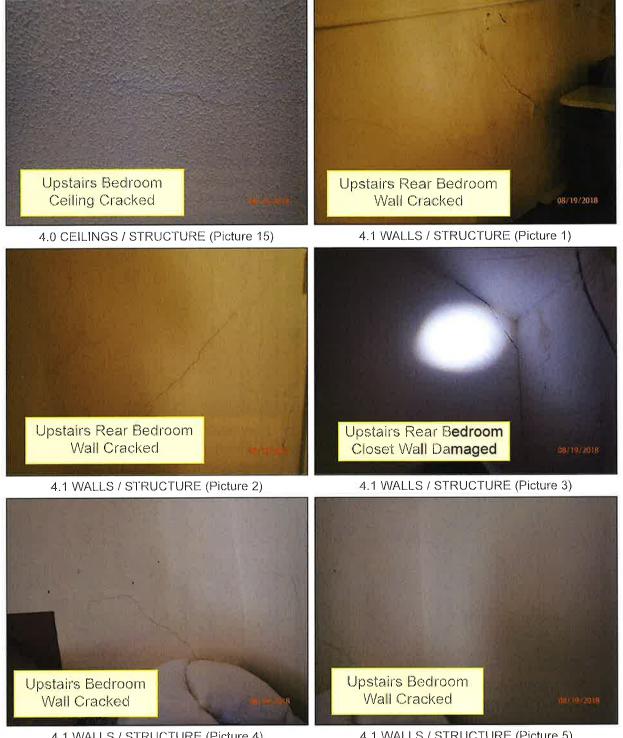
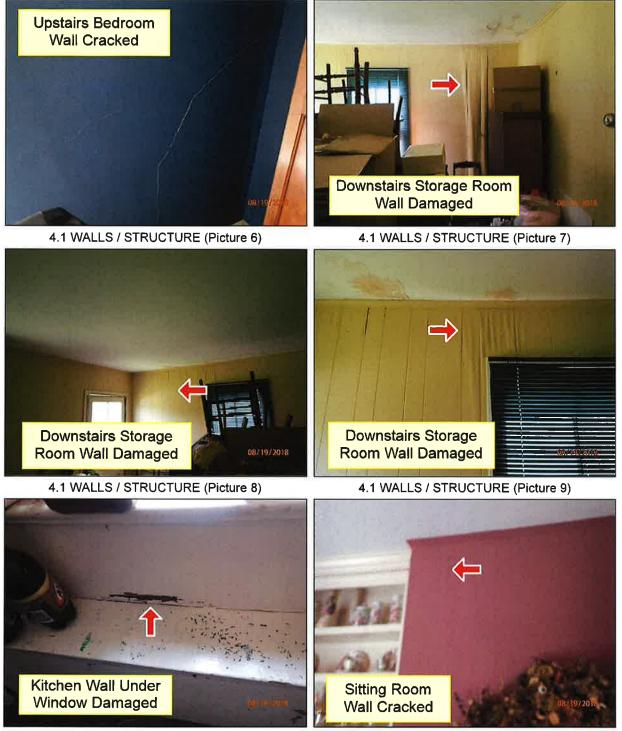
4.1 WALLS / STRUCTURE (Picture 4)

Walls throughout the structure are cracked and/or damaged. This may be a sign of water infiltration as the cracks are in the area of prior noted ceiling damage as well and under windows with prior noted significant damage to the frames.

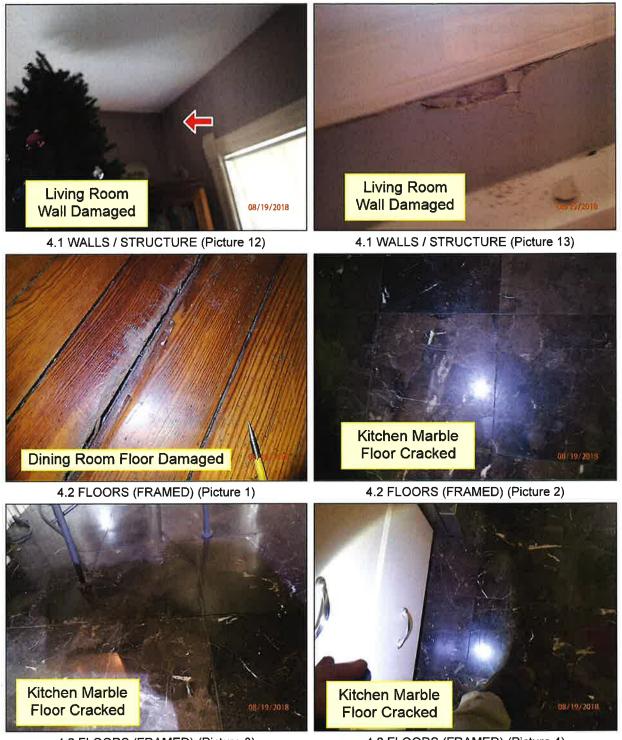
4.2 FLOORS (FRAMED) (Picture 3)

The dining room floor has a spot of damage consistent with wood destroying insects.

The sitting room floor has a separation gap where the foundation ends and the cantilevered bumpout begins. This may be a sign of significant damage to the framing below the floor. The sitting room bumpout has significant damage to the framing and wooden trim as well.
