# ARCHITECTURAL REVIEW BOARD

## REGULAR MEETING ~ AGENDA ~

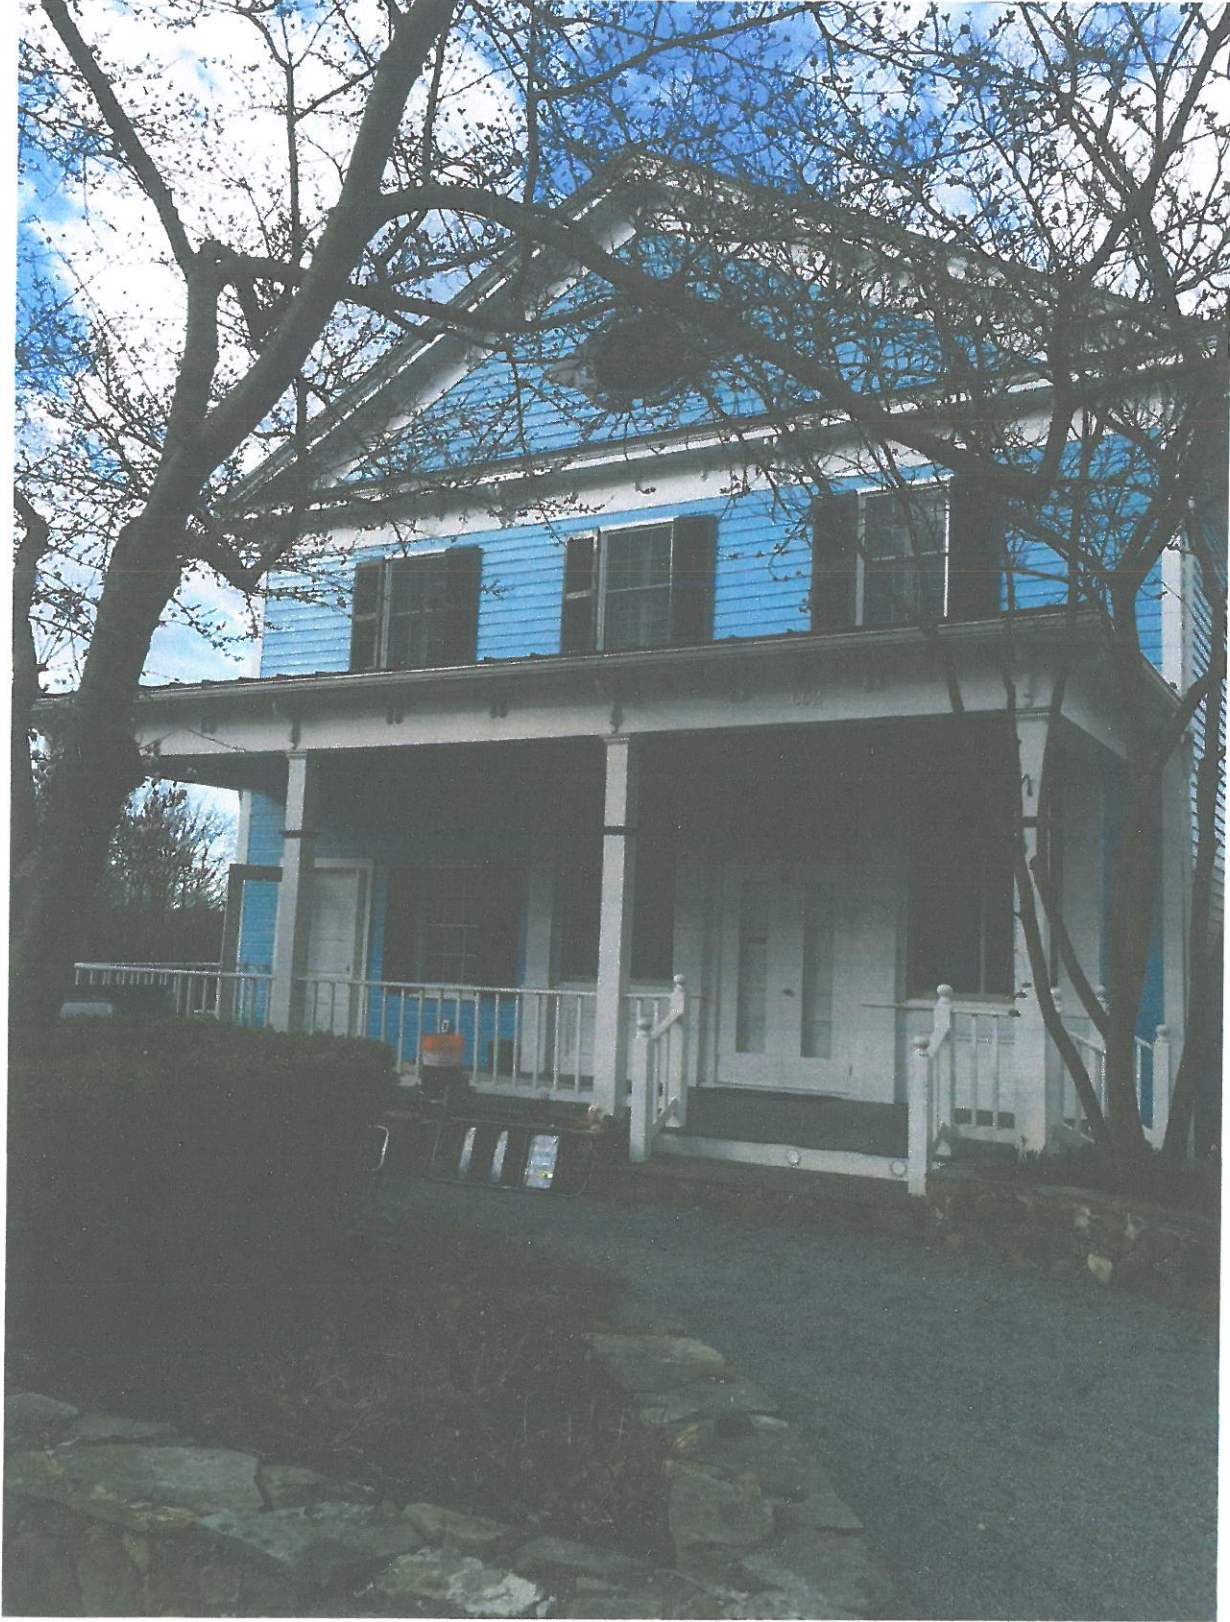
Attachment: Project Madison St - Exhibits (3096 : 6760 Madison Street - Demolition of a Rear Addition ZP2017-006)

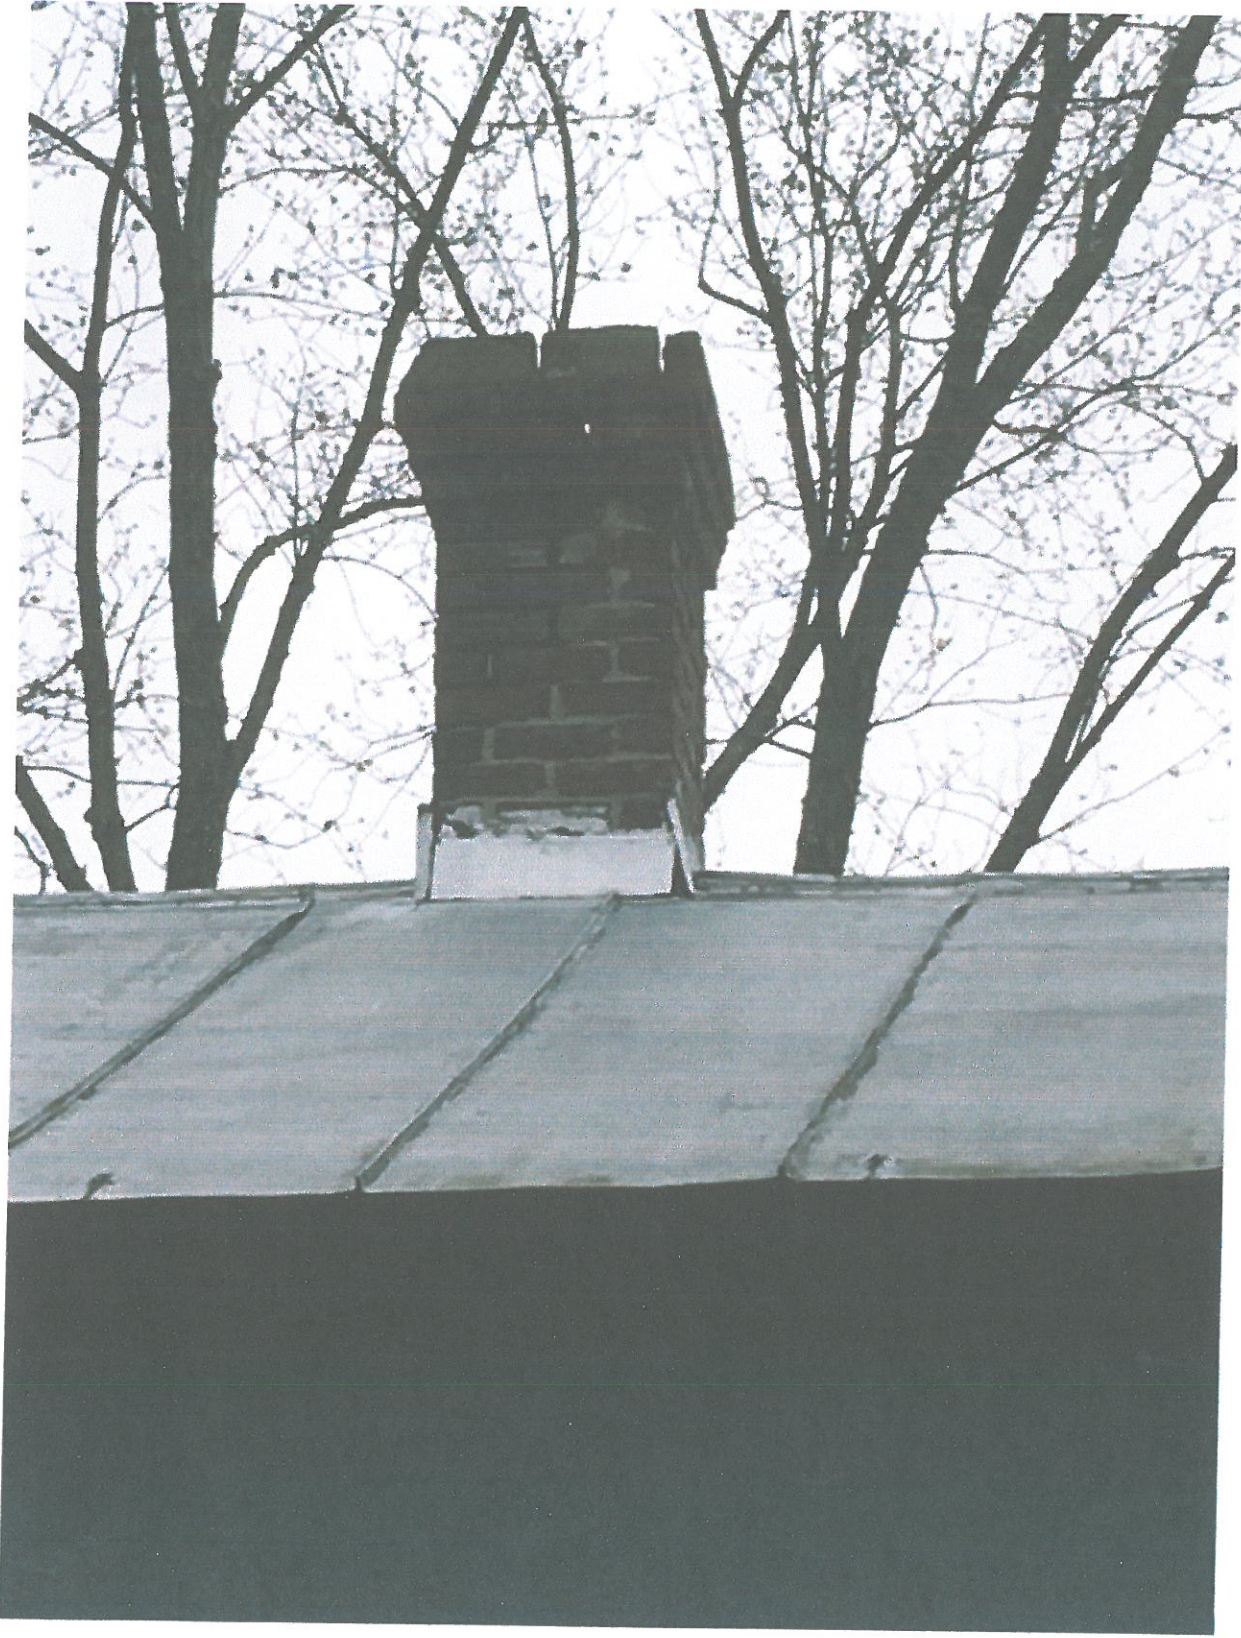
#2 View THROUGH TERRACOTA sleeve  
SHOWS REAR WALL BRICK AND  
EXTREME CREOSOTE BUILDUP

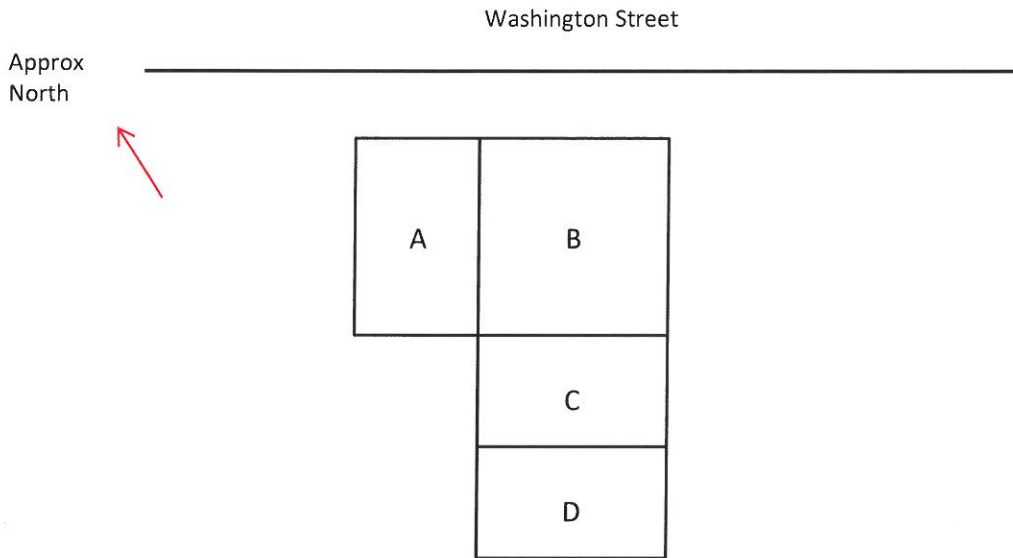
Diagram A – Areas of the existing building

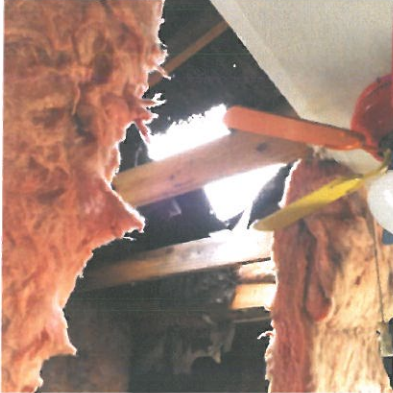
Photo 2 – Hole in roof

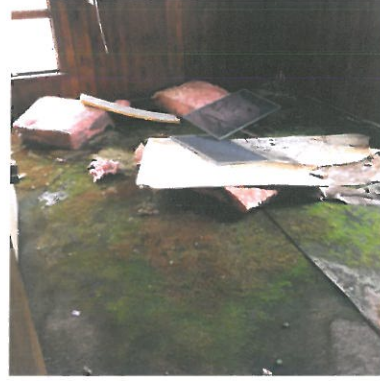
Photo 4 –Algae growth

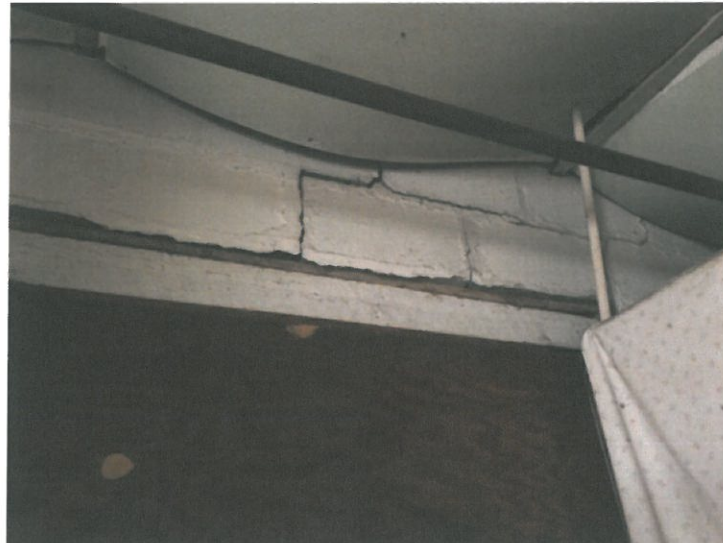
Photo 5 – masonry failure between Area A and B

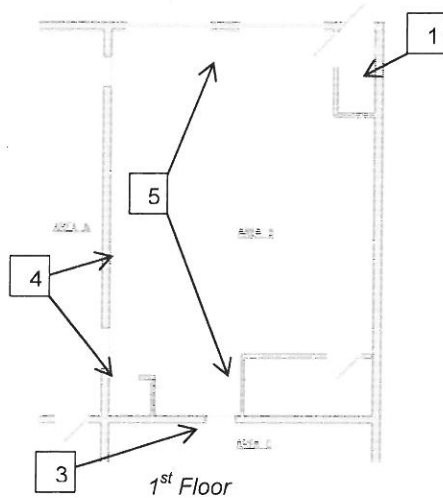
Diagram C – Area B first and second floor (not to scale). See keynotes below.

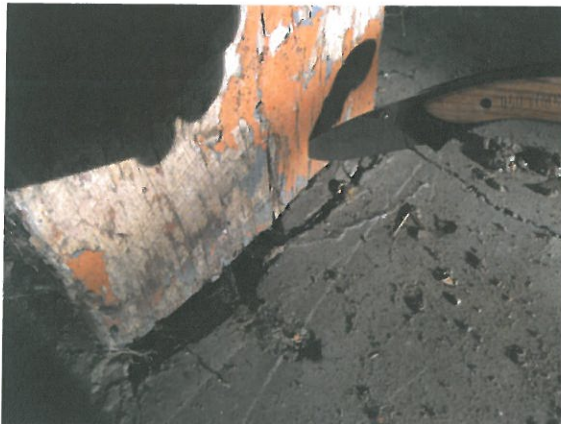
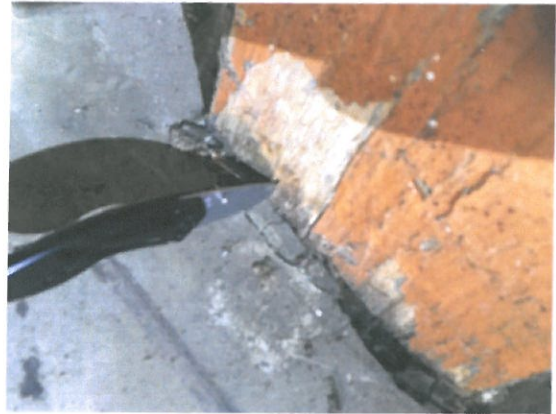
*Photographs 6 and 7 showing dry rot at base of wood posts*

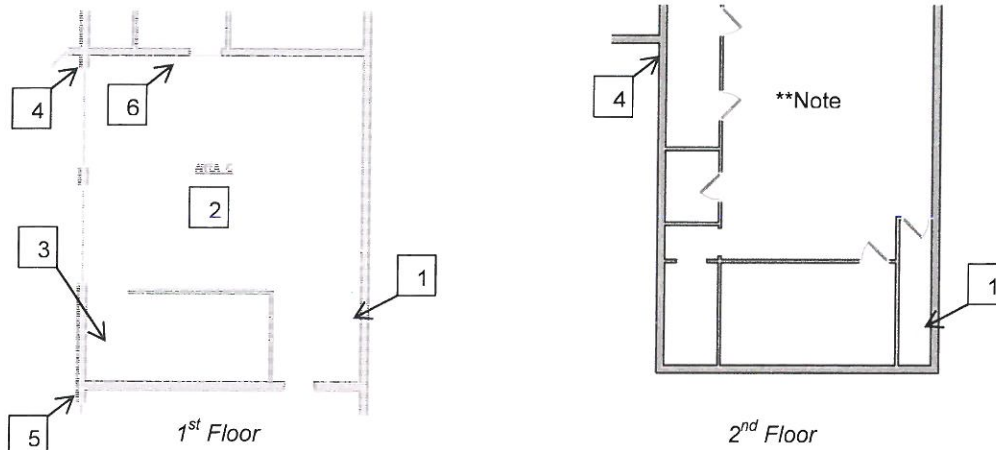
Diagram D – Area C first and second floor (not to scale). See keynotes below.

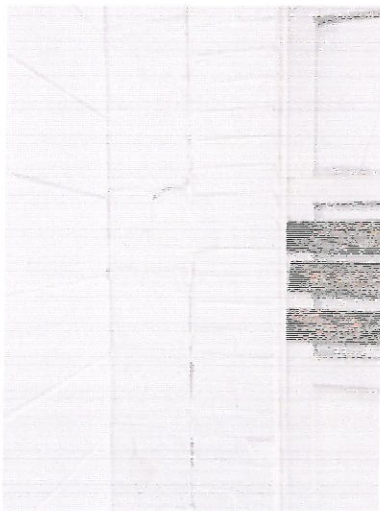
Photo 8 – Stress crack between Area B and C

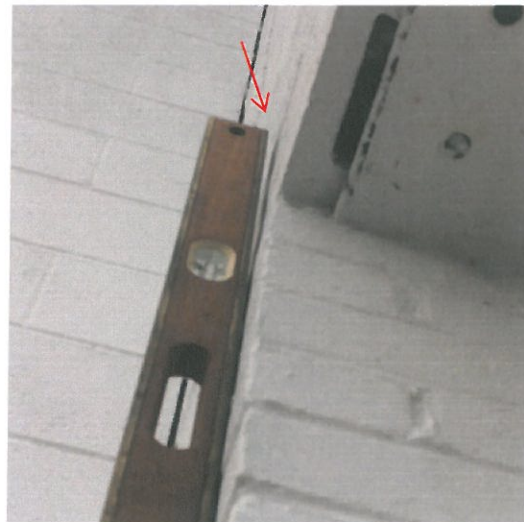
Photo 9 – “Belly” in exterior wall

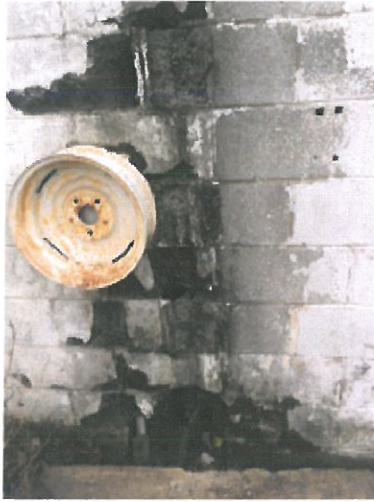
Photo 10 – Deteriorated exterior wall

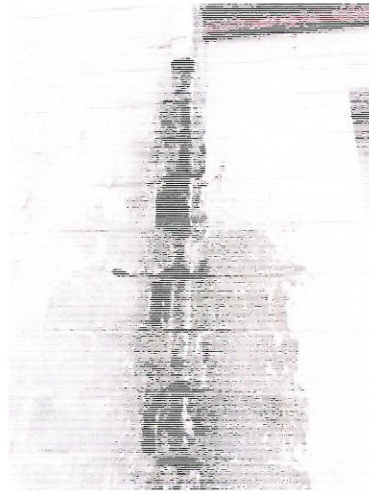
Photo 11 – Deteriorated exterior wall

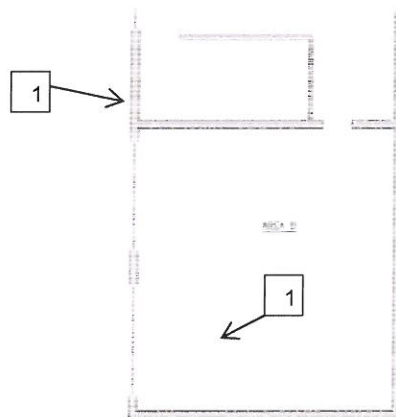
Diagram E – Area D first floor (not to scale). See keynotes below.

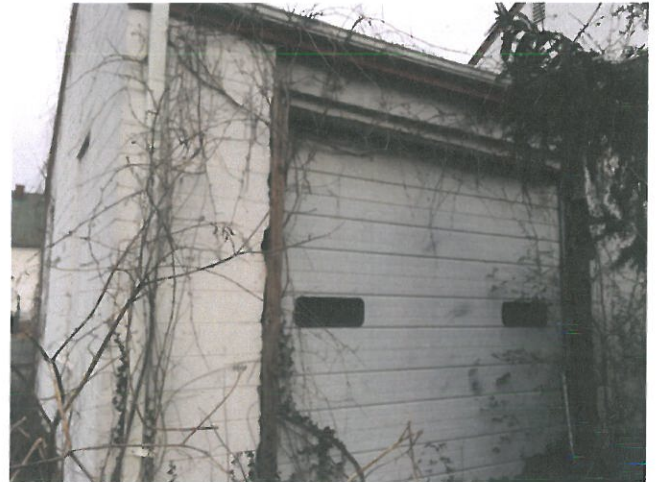
Photo 15 – Southeast Corner (rear)

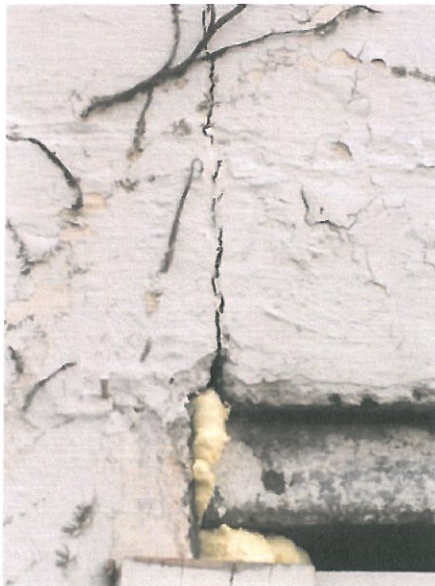
Photo 16 – Foundation cracks

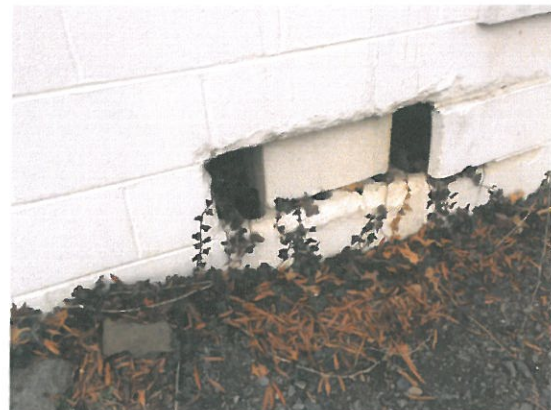
Photo 17 – Foundation penetrations

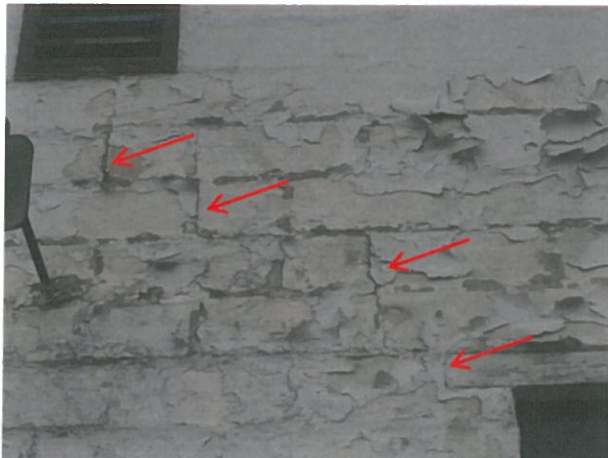
*Photo 18 – Stair stepping cracks (red arrow) migrating through heavily painted masonry. Paint underlayment suspected to be lead based. Notice wood lintel.*

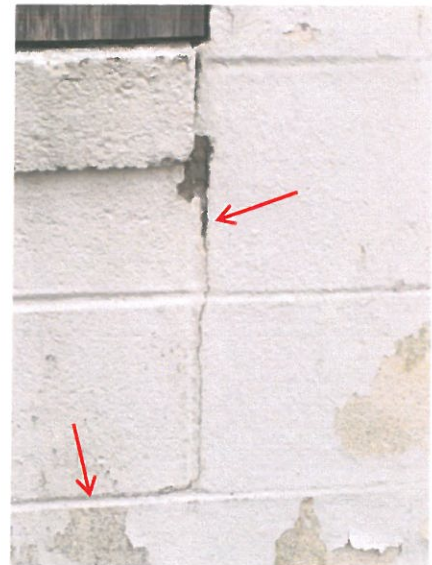
*Photo 19 – Early signs of stress*

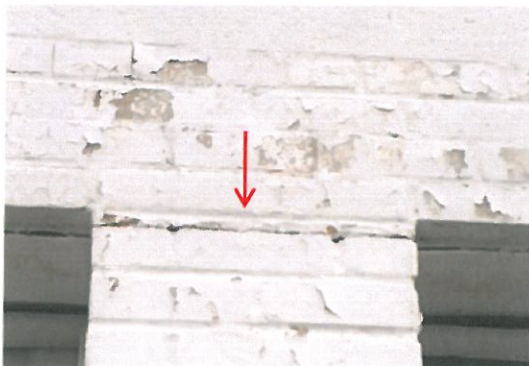
*Photo 20 – Stress crack at head of door opening*

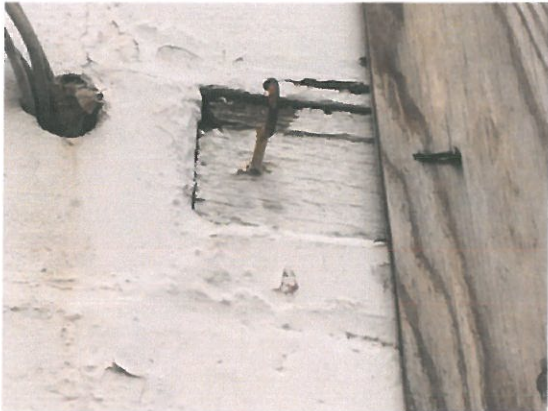
*Photo 21A – Wood Lintel, early stages of rot*

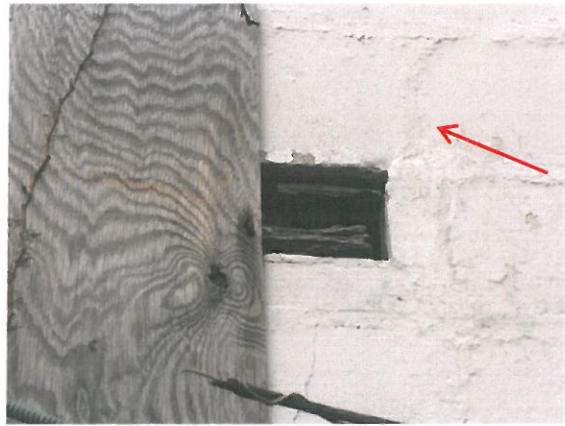
*Photo 23 – Completely rotted wood lintel with evidence of patched wall fail (red arrow)*

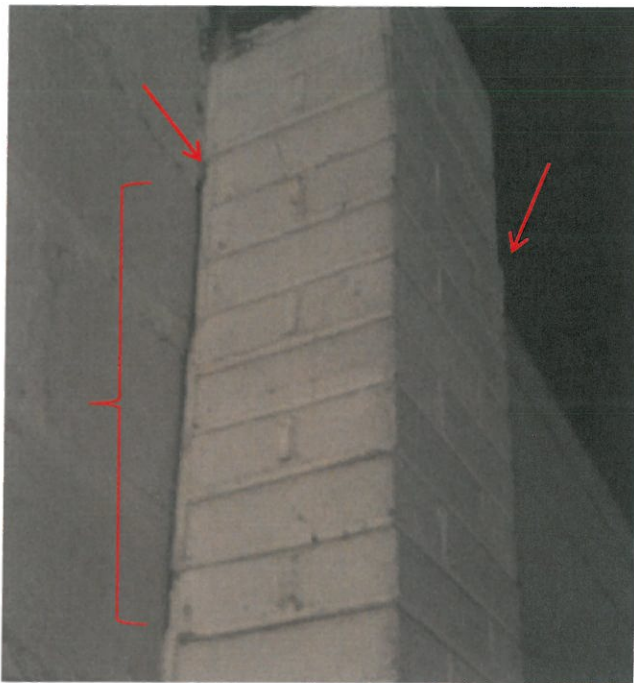
Photo 23 – Brick pier horizontal shift at top 1/3 point  
See red arrows.

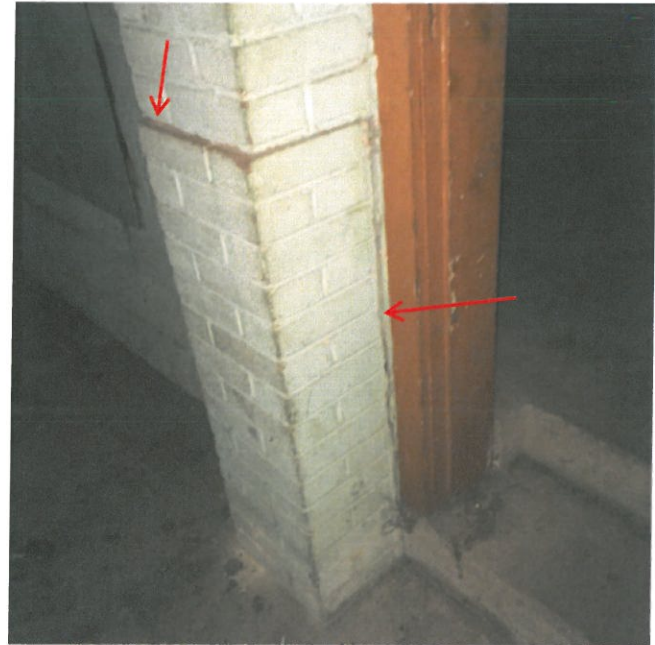
Photo 24 – Brick pier horizontal shift at mid- point. See red arrows

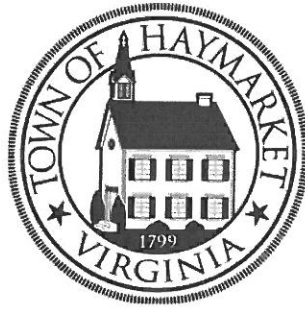
**Town of Haymarket  
15000 Washington Street, #100  
Haymarket, VA 20169  
703-753-2600**

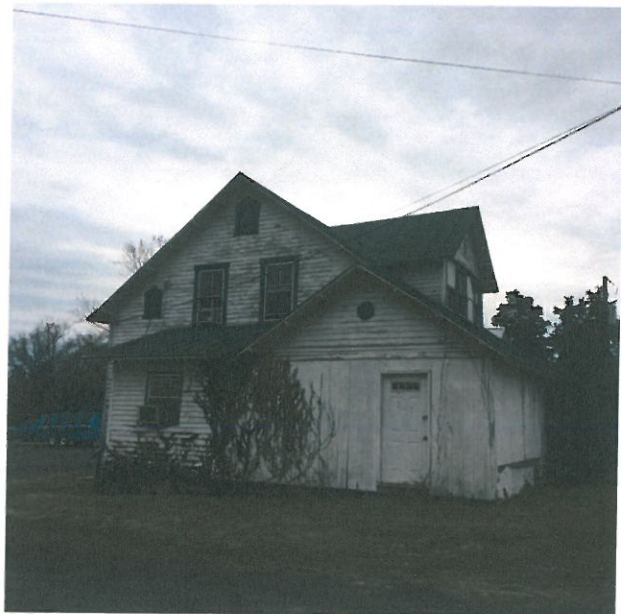
*Photo 1 – View from Jefferson Street*

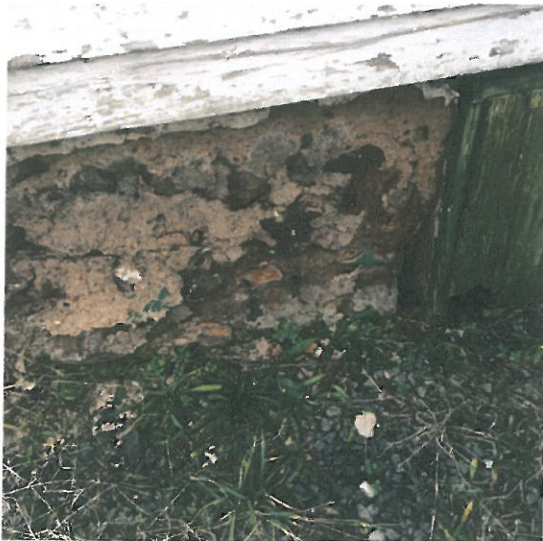
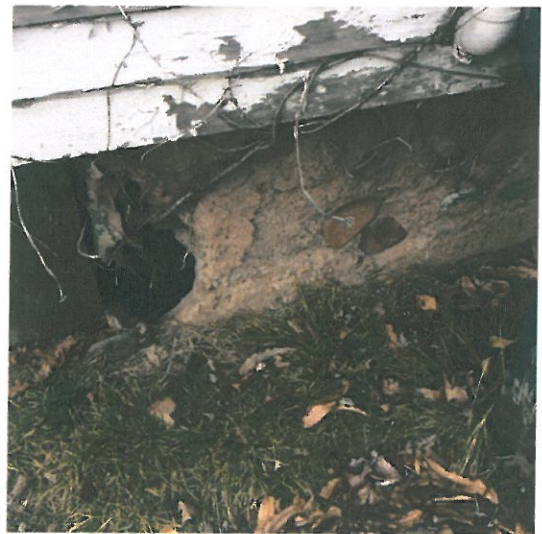
*Photos 1 and 2 – Skim coat of parging has failed allowing moisture infiltration. Freeze thaw cycles have resulted in parging failure and greater amount of moisture to penetrate the wall. Moisture in the wall allows the decay to penetrate further into the wall composition resulting in cracking and eventual collapse.*

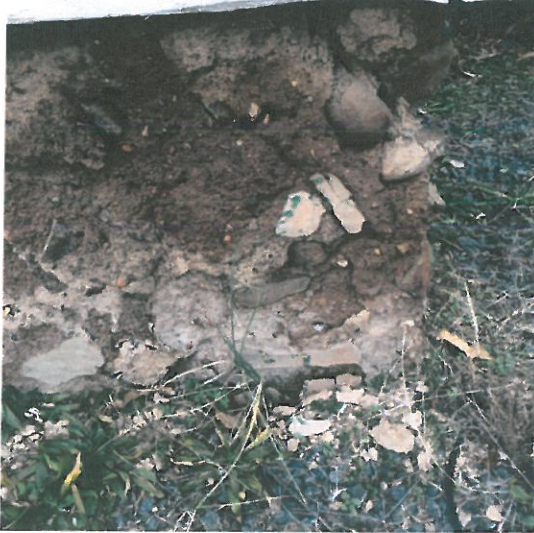
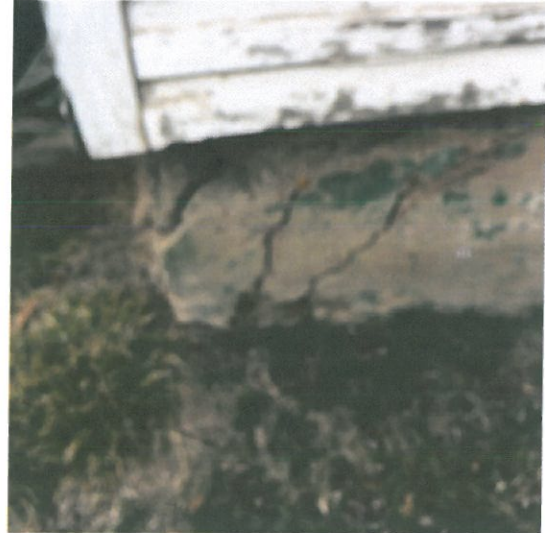
Photos 3 and 4 show the longer term decay associated with moisture penetration and degradation of sand based mortars. The foundation for the building is failing requiring immediate attention to prevent collapse. Remedies include temporary cribbing or demolition of the building.

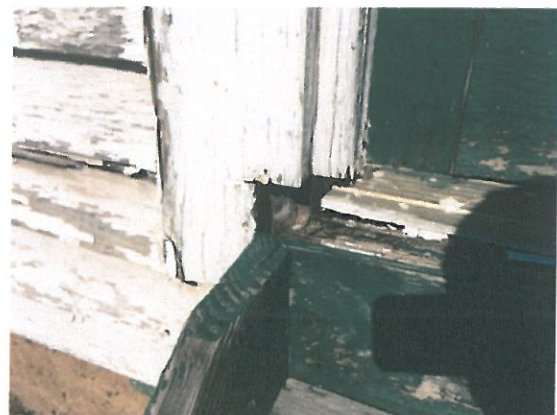
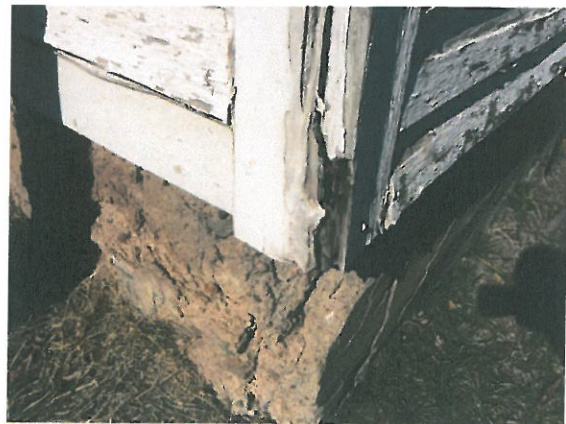
Photos 3 and 4 – examples of rotted trim and plates

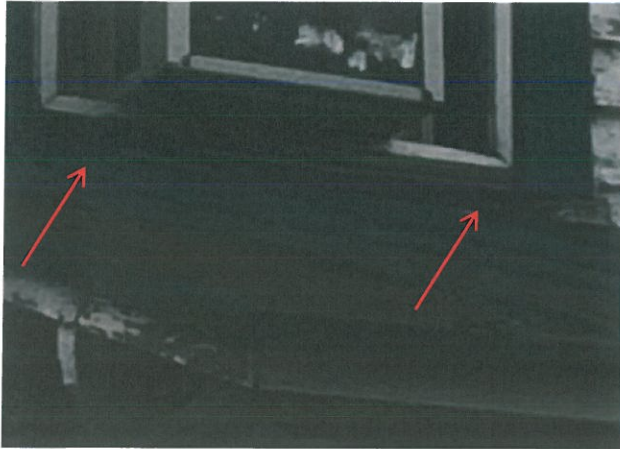
*Photo 5 – Moisture penetration and resulting rot at window opening*

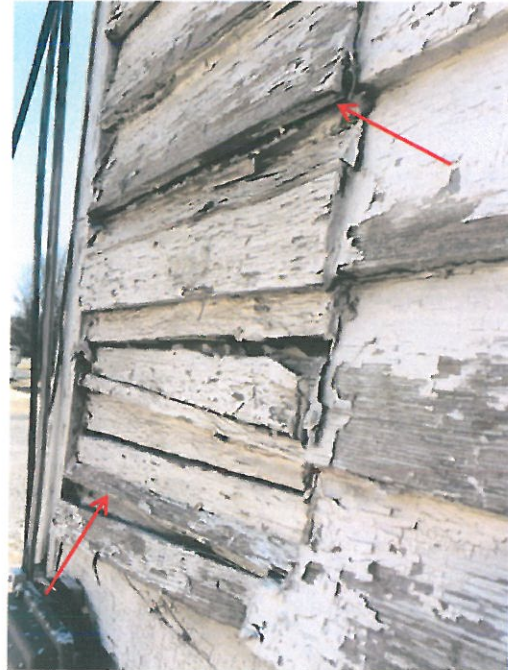
*Photo 6 – Moisture penetration and rot at wood siding, leading to delamination of siding from the wall*

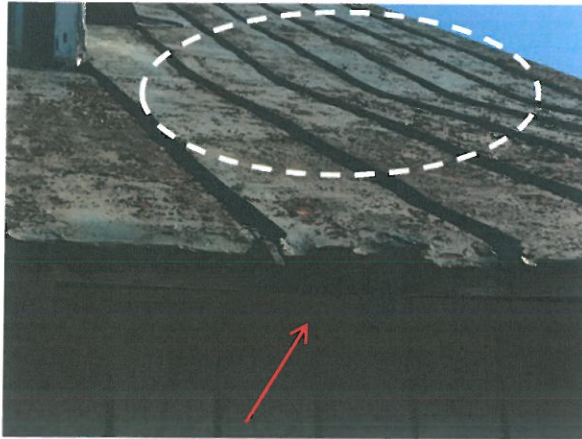
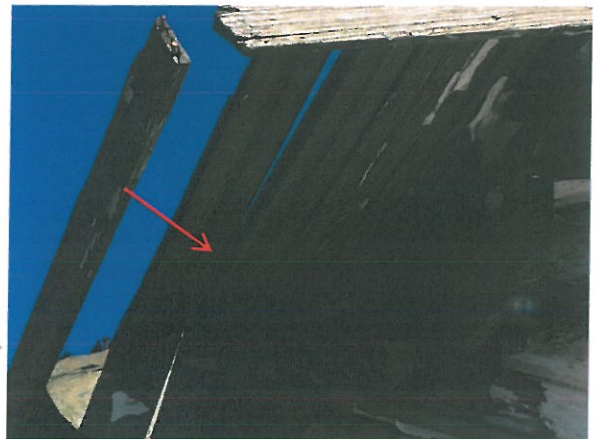
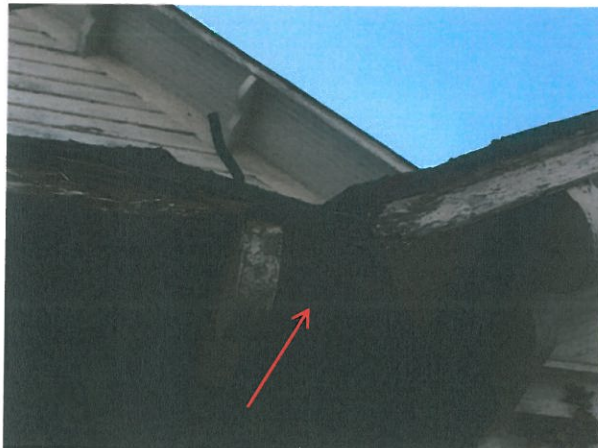
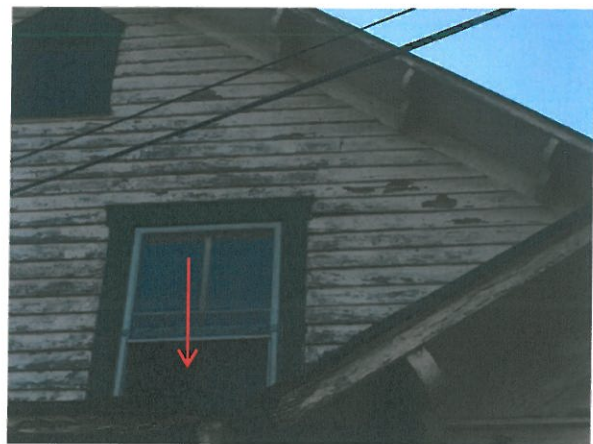
#### 4. SUMMARY OF CONSIDERATIONS

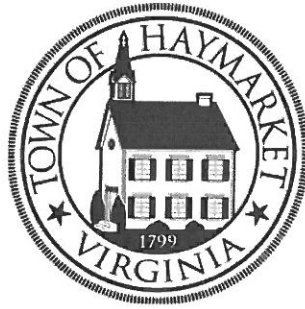
**Town of Haymarket  
15000 Washington Street, #100  
Haymarket, VA 20169  
703-753-2600**
