PHASE I ENVIRONMENTAL SITE ASSESSMENT

**Smith Property
Town of Haymarket, Virginia
ECC Project #18-13435
January 15, 2019**

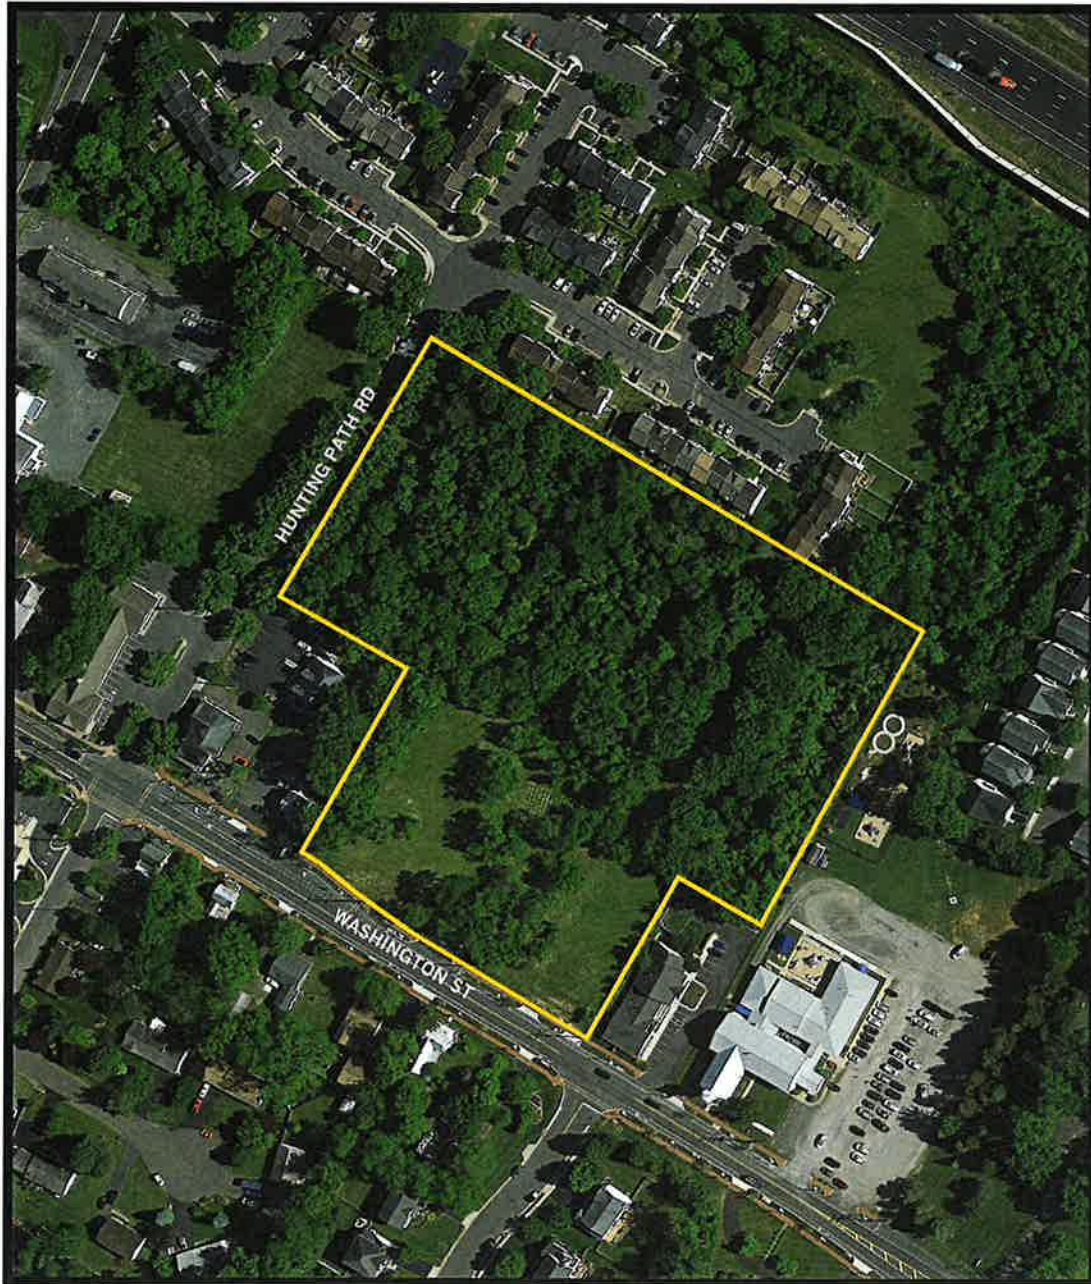
FIGURE 2

2018 AERIAL IMAGERY PROVIDED BY GOOGLE EARTH

The Subject Property is located on the northeast side of Washington Street and the southeast side of Hunting Path Road, in the City of Haymarket, Virginia. The Subject Property consist of three parcels identified as Prince William County GPIN Number 7297-99-8684 (addressed 14680 Washington Street), 7397-09-0978 (addressed 14850 Washington Street), and 7298-90-7006 (addressed 6701 Hunting Path Road). The Subject Property is located in ZIP Code area 20169, and is centered at approximately 38°48'43" North latitude and 77°37'59" West longitude. A Site Location Map and Site Plan are presented as Figure 1 and Figure 2, respectively.

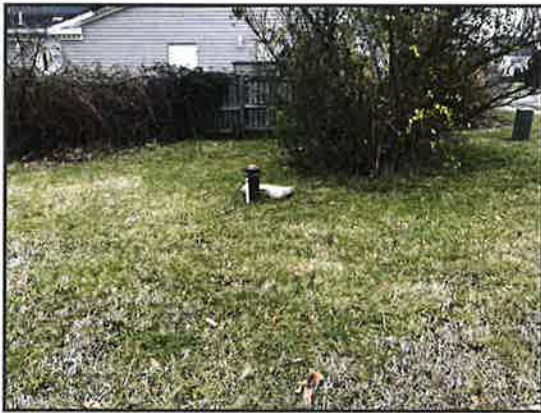
ECC observed a potable well on the southern corner of the Subject Property. The potable well served the former residence on the southern corner of the Subject Property. The potable well did not appear to be properly abandoned.

PHOTO 1: Potable Well on the Subject Property

ECC recommends abandoning the potable well in accordance with applicable Prince William County regulations prior to redevelopment.

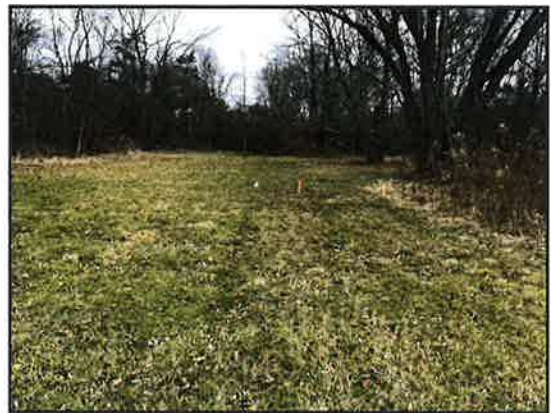
ECC observed white and orange boring location markers throughout the Subject Property. The boring markers are likely associated with a geotechnical investigation of the Subject Property.

PHOTO 2: Boring Markers

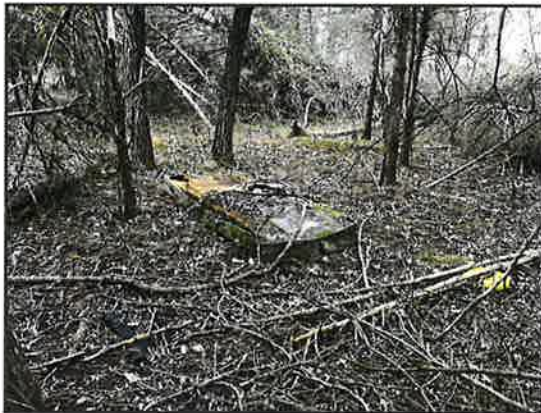
ECC observed trash and miscellaneous debris on the northern portion of the Subject Property. Some of the debris appeared to be relatively modern and may have been dumped on the Subject Property by residents of the north-adjacent town homes. The remainder of the debris was old and partially buried by accumulated leaf litter, and was likely dumped on the Subject Property by its past occupants. ECC observed a pile of metal and wood debris on Parcel 7298-90-7006 that appeared to be the remnant of an outbuilding/shed that was previously located on the Subject Property.

PHOTO 3: Debris near north-adjacent townhomes

ECC recommends removing and properly disposing of all scattered debris on the Subject Property prior to redevelopment. If previously undetected drums, USTs, other containers, or discolored or otherwise contaminated soils are encountered during any future excavation or construction development, a determination should be made concerning the origin and nature of the contamination.

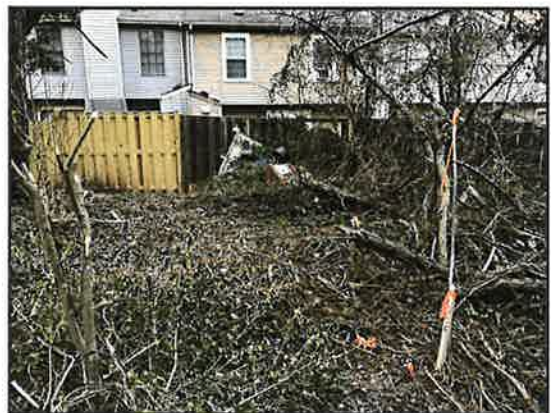
PHOTO 4: Debris adjaent to townhomes

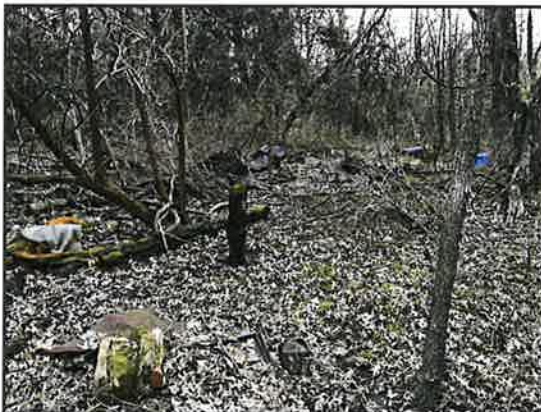
The northern portion of the Subject Property consisted of unimproved, wooded land. ECC observed a ruined wooden fence that previously divided Parcel 7397-09-0978 and 7297-99-8684, and a pile of wooden debris at the southern end of the fence line. ECC observed scattered household trash and debris on the northern portion of the Subject Property. Based on the location and type of trash/debris, some of it may have been dumped on the Subject Property by residents of the north-adjacent town homes. The remainder of the debris was old and partially buried by accumulated leaf litter, and was likely dumped on the Subject Property by its past occupants. ECC observed a pile of metal and wood debris on Parcel 7298-90-7006 that appeared to be the remnant of an outbuilding/shed that was previously located on the Subject Property.

PHOTO 5: Debris on northwest portion of the Subject Property

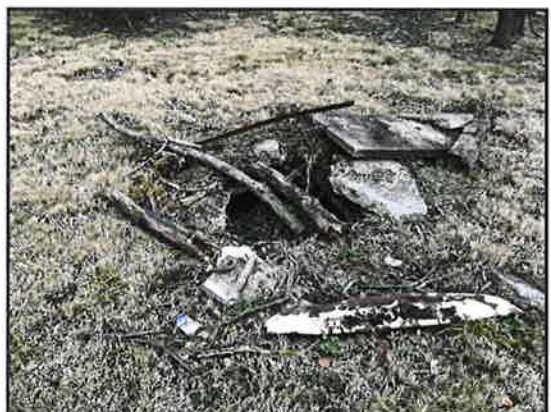
At the time of the inspection, the southern portion of the Subject Property consisted of primarily unimproved, open land. The southern portion of the Subject Property was well maintained and free of trash and debris. ECC observed a potable well on the southern corner of the Subject Property, adjacent to Washington Street. Historical records indicate that two residences were previously located on the southern portion of the Subject Property (at different times). ECC observed uneven ground and some concrete and stone rubble in the vicinity of the former residences. ECC also observed an in-ground concrete structure in the vicinity of the former residences. The concrete structure appears to be located north of the original residence (constructed prior to 1933) and may have been a cistern or old septic system connected to the residence.

PHOTO 6: In-Ground Concrete Structure
