TOWN OF HAYMARKET TOWN COUNCIL

WORK SESSION
~ AGENDA ~

Monday, November 5, 2018

1. Haymarket Historic Foundation
2. Architectural Review Board Appeal - 14801 Washington Street

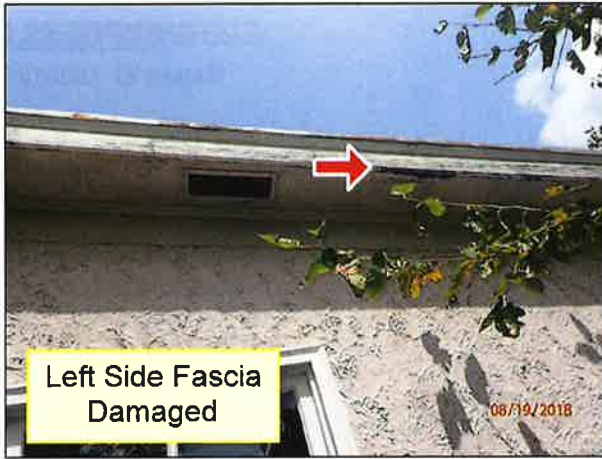
1.1 FASCIA / SOFFITS (Picture 2)

Decay noted on fascia boards on all sides of the structure with major damage along the right side where the rear addition is connected to the primary structure and the rear left corner of the addition. This damage is not visible from the attic as it is primarily associated with how the addition was attached to the main home. However, the visual damage to the fascia boards and associated rafters is quite extensive and may include adjoining rafters as well.

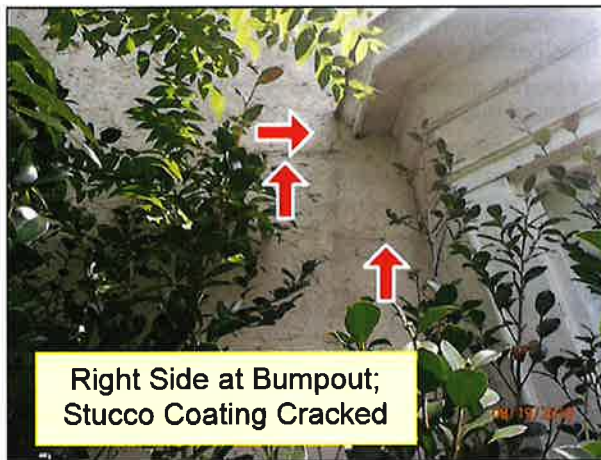
2.0 SIDING / WALL CLADDING (Picture 2)

Several cracks were noted in the stucco coating throughout the outside of the structure with several points where internal structural damaged was noted including;

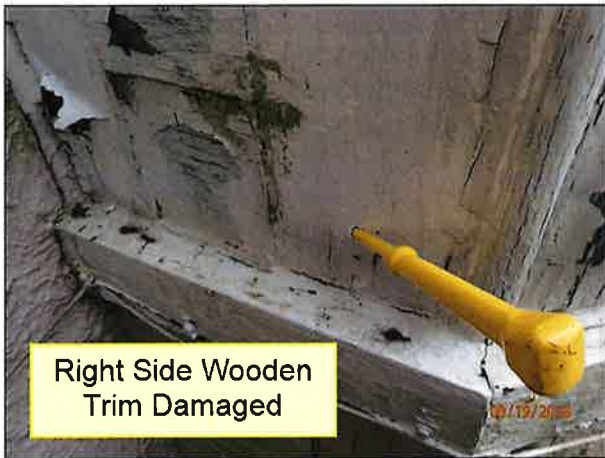
2.1 WOOD TRIM / WRAPS (Picture 3)

Virtually all exterior wooden trim has been damaged by a combination of wood destroying insects and water intrusion.

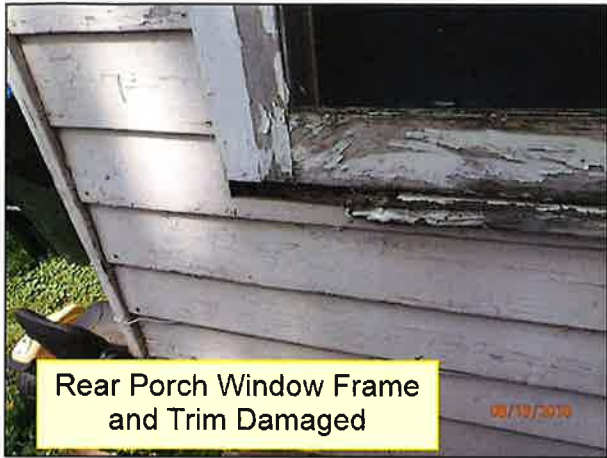
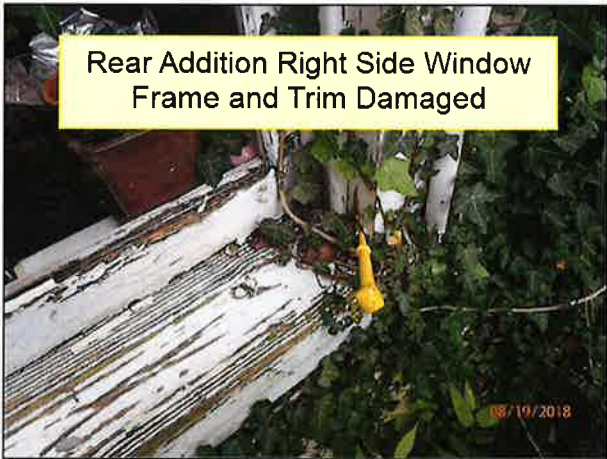
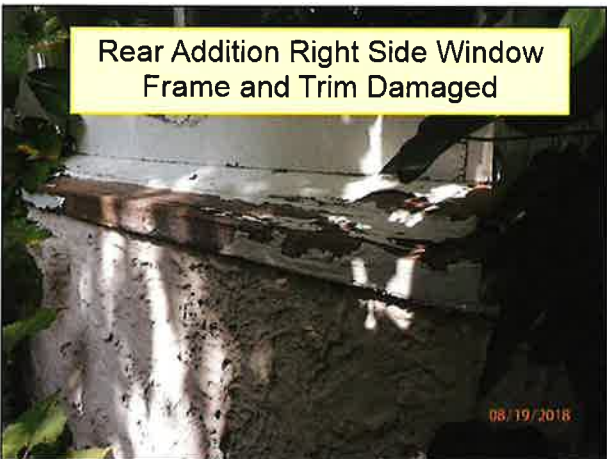
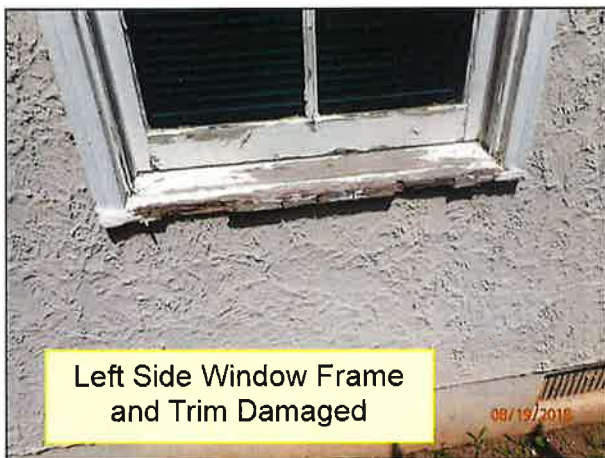
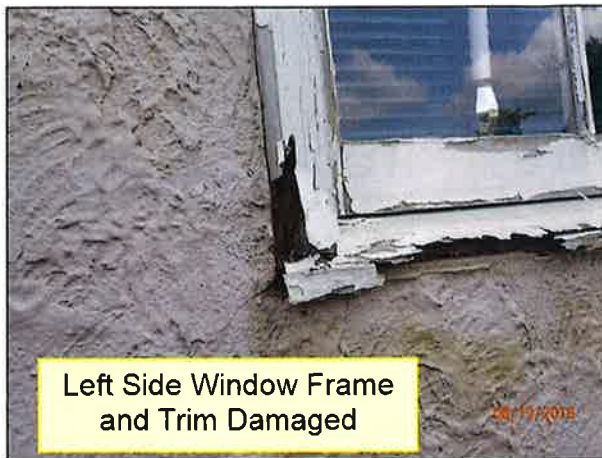
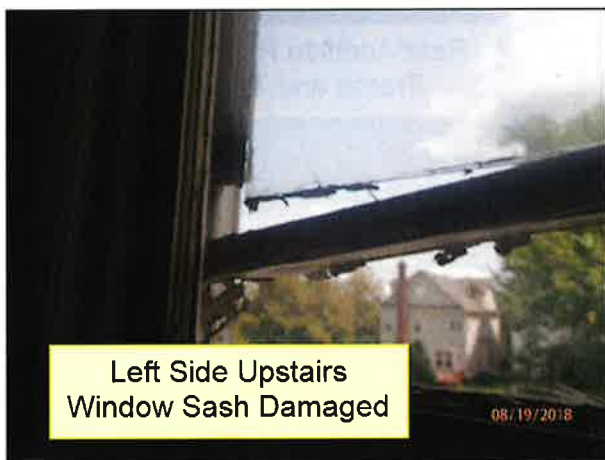
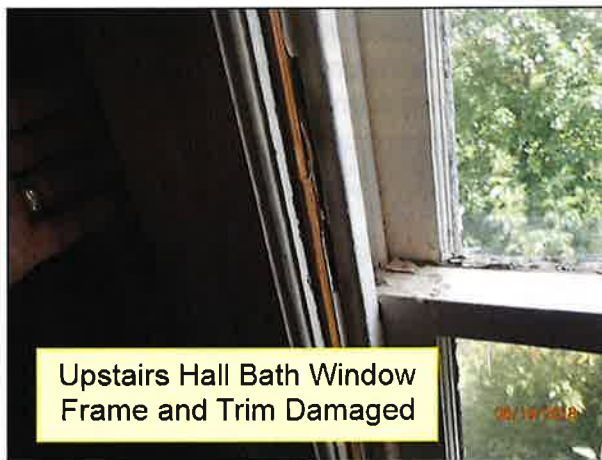
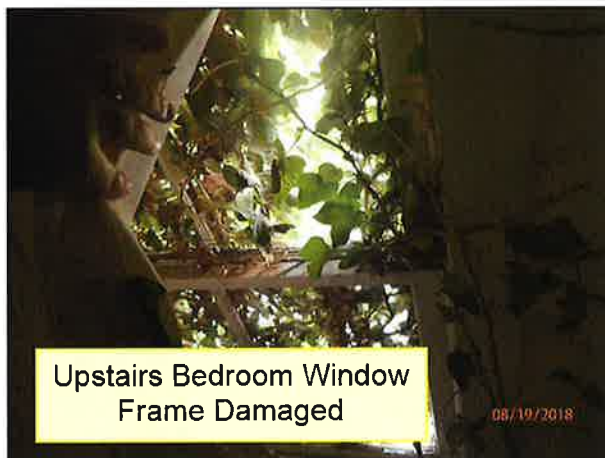
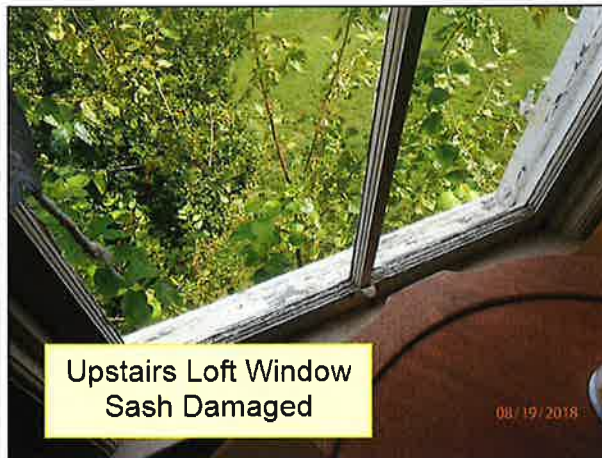
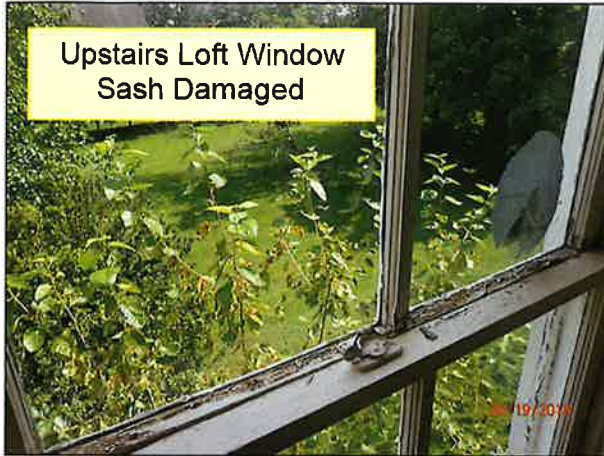
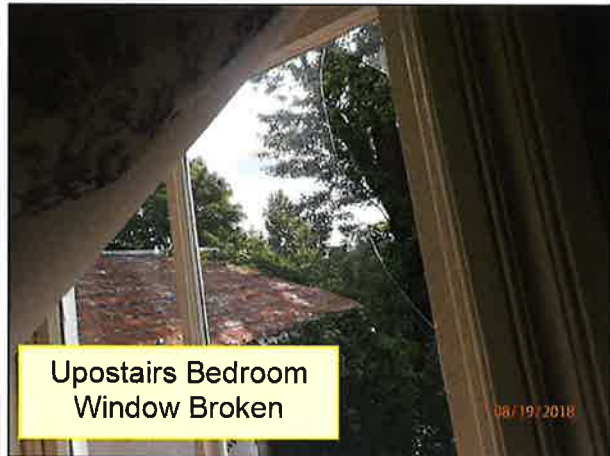
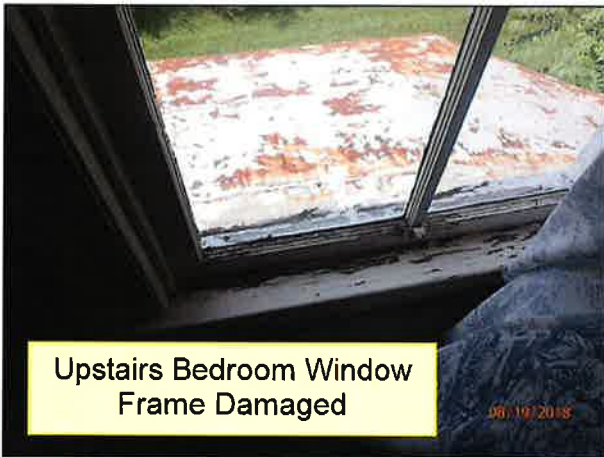
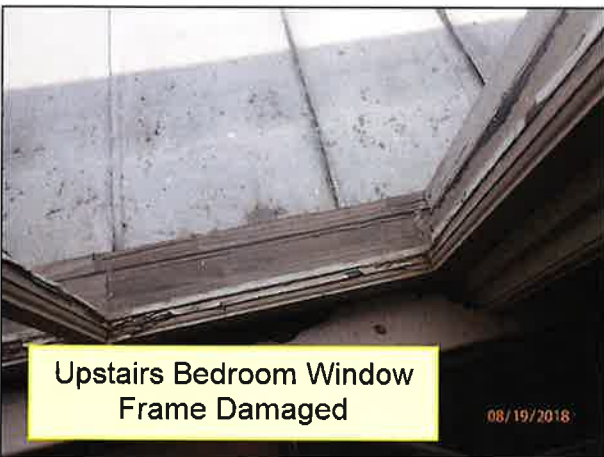
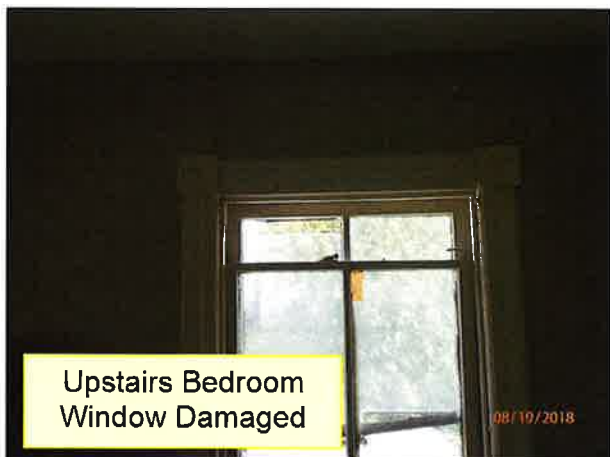
Virtually all window frames and trim has been damaged by a combination of wood destroying insects and water intrusion.

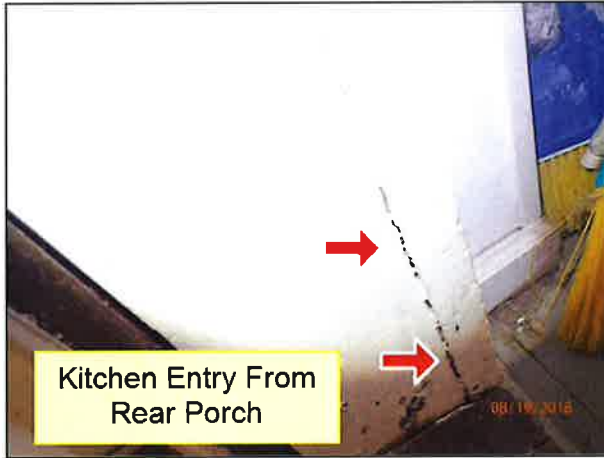
Kitchen Entry From Rear Porch

Kitchen entry door from rear porch has a damaged frame and trim. Wood destroying insects have damaged the framing behind the trim such that frass is being extruded from the gaps in the frame.

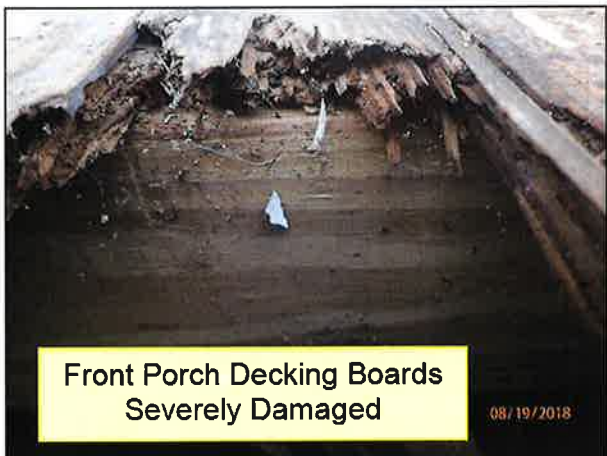
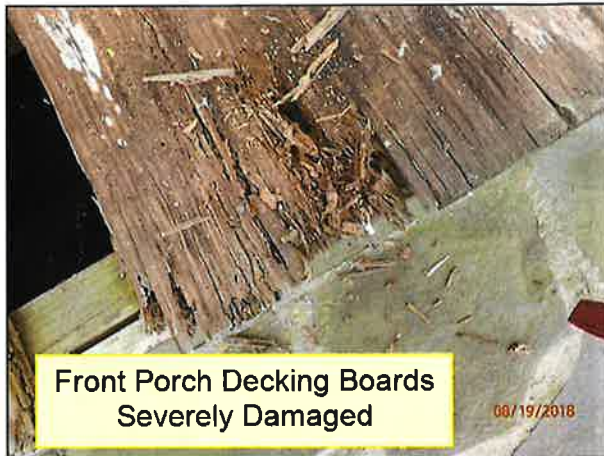
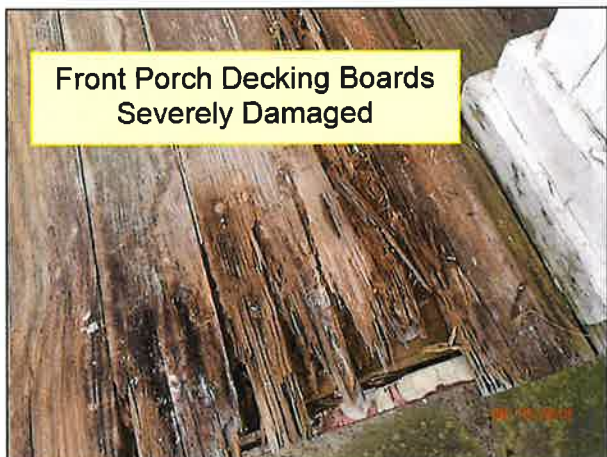
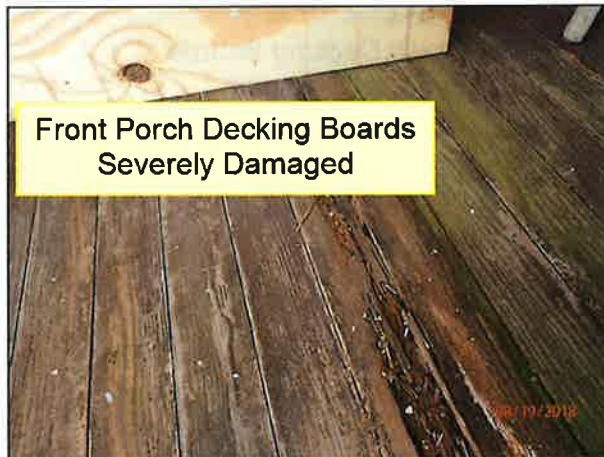
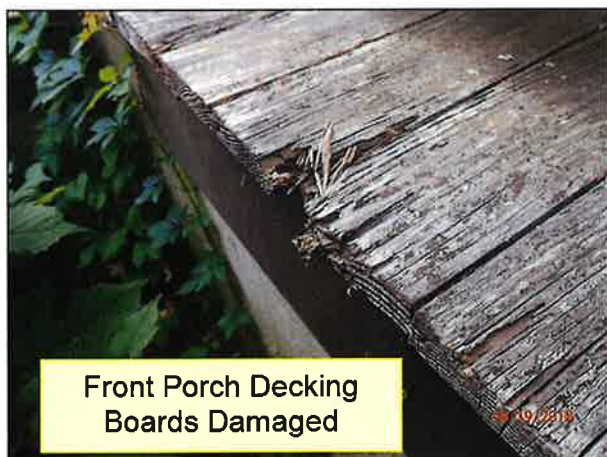
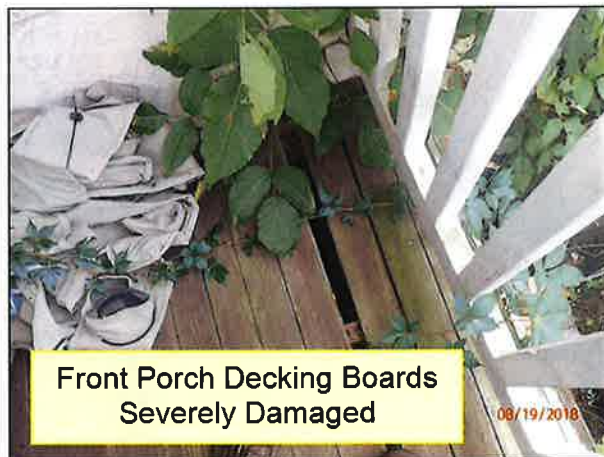
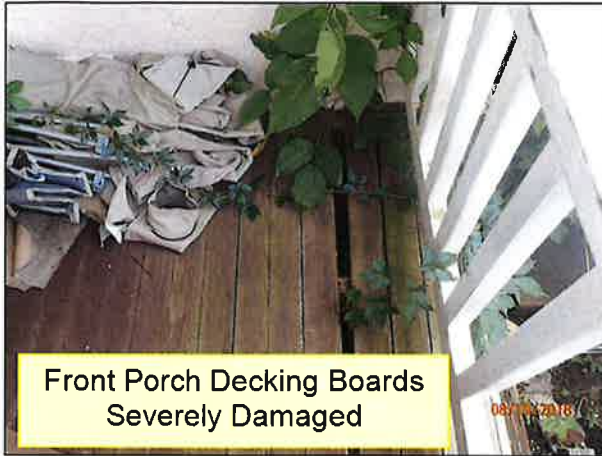
The deck of the front porch is severely damaged by a combination of wood destroying insects and water intrusion.
